### Architectural & Site Condition Assessment

Prince Edward Collegiate Institute, Building ID 8347-1

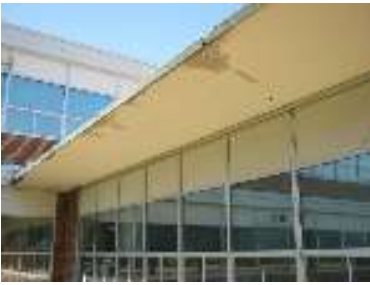
2012 - The light weight concrete deck Siporex is in poor condition. The deck was noted to be cracked and deteriorated during the time of assessment.

August 2012 - General view of light weight concrete deck

2012 - A study is recommended to determine the cause of the cracking noted and to determine the structural adequacy of the building structural elements. Deferral of the study could result in further deterioration, which may affect the structural performance of the building. The study should include repair options along with associated construction costs.

2012 - Replacement cost provided is for budgeting purposes only and is subject to the conclusions of the recommended study. Failure to undertake the recommended remedial work may result in further deterioration of the building structure.

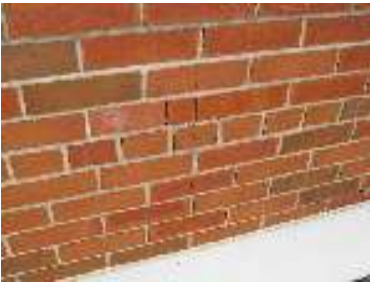
2012 - The exterior wall system is generally in poor condition. Areas of efflorescence were observed on the face of the brick and areas of cracking were observed in the face of the brick and within mortar joints which are located on the north elevation of the building in both stairwell block of the addition 2. The brick wall system is in poor overall condition. At the time of the assessment, areas of brick deterioration were noted in the form of spalled and cracked bricks. The mortar joints are also in poor condition, with areas of deteriorated mortar noted, typically in the same areas as the deteriorated brick.

August 2012 - Cracks on brick wall observed

2012 – Areas of efflorescence on the face of the brick veneer were observed. Failure to undertake the recommended remedial work may result in further moisture intrusion within the building envelope and accelerated deterioration of the exterior wall system. Areas of vertical and step cracking were observed in the brick veneer. It is recommended that the deteriorated sections of brick be repaired, the repairs may involve crack sealing, localized replacement of brick units, and repointing of mortar. In order to maintain the intended performance of the wall system, it is recommended that the brick wall be repaired, which will require mortar repointing and occasional brick replacement.

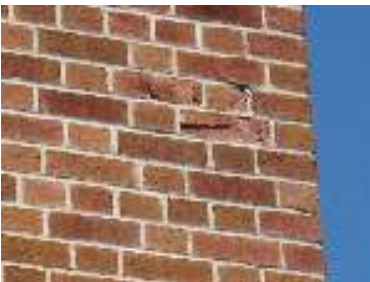
August 2012 - Appearance of spalled bricks

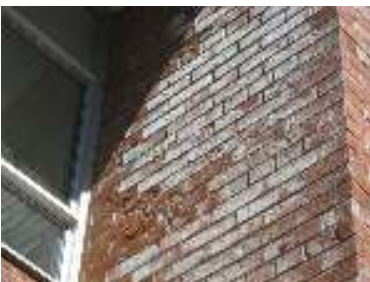
August 2012 - Efflorescence and deteriorated brick wall observed

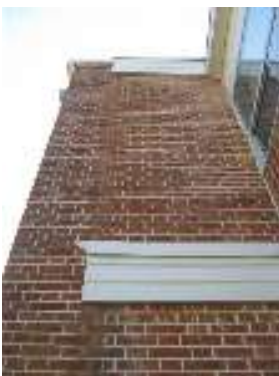
August 2012 - Past repairs observed

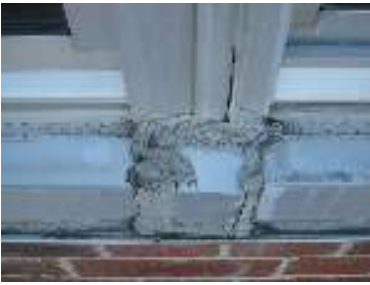
2012 - The sealant is in fair condition. The sealant observed has lost elasticity and exhibits adhesive and cohesive failure.

August 2012 - Cracked and deteriorated sealant observed

2012 – The sealant has exceeded its expected useful life. In order to maintain the performance of the building's exterior envelope, replacement of the sealant is recommended.

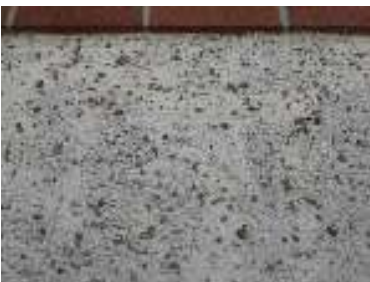
2012 - The stucco coating on the exterior walls is in fair condition. At the time of the assessment, cracked, spalled and deteriorated areas of stucco coat were observed.

August 2012 - Appearance of crack in stucco coat

2012 – The stucco coating has exceeded its expected useful life. Based on age and observed condition, replacement is recommended.

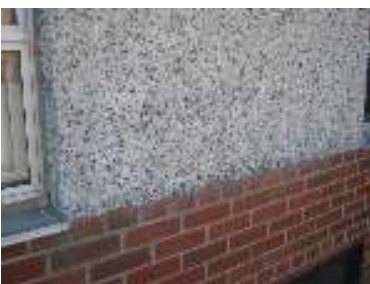
August 2012 - Spalled and deteriorated stucco coat observed

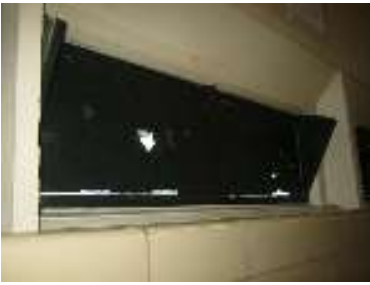
2012 – The windows of Gymnasium B are in poor overall condition, with an aged appearance and deteriorating frames.

August 2012 - Damaged and deteriorated window observed

2012 - The windows of Gymnasium B have exceeded their expected useful life. Based on the age and observed condition, replacement of these windows is recommended.

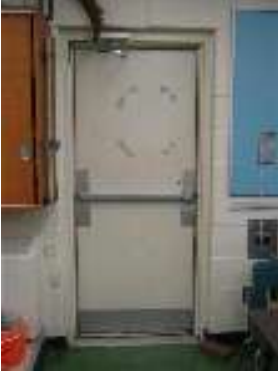
2012 - Approximately one aluminum main door and nine hollow metal exterior doors and frames of the building appear to be in fair overall condition, with faded paint, corrosion, damage, wear and a generally aged appearance.

August 2012 - Aged and worn appearance of exterior metal door

2012 - Approximately one aluminum main door and nine hollow metal exterior doors and frames of the building are beyond their expected useful life. Based on age and observed condition, replacement of the exterior doors and frames is recommended.

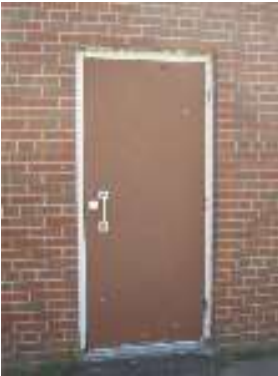
August 2012 - Faded paint and corroded exterior door observed

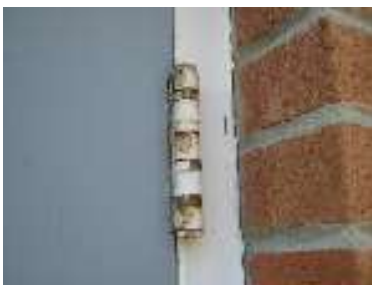
2012 - The exterior door hardware of one aluminum main door and nine exterior metal doors is in fair overall condition, with corrosion and wear typical of its age.

August 2012 - Corroded and aged butt hinge observed

2012 - The exterior door hardware of one aluminum main door and nine exterior metal doors has exceeded its expected useful life. Based on age and observed condition, replacement of the exterior door hardware is recommended.

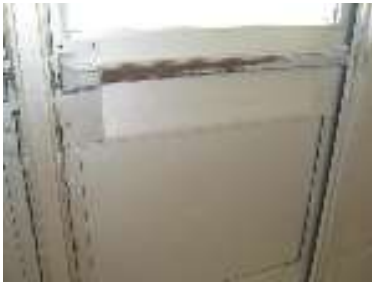
August 2012 - Worn appearance of touch bar

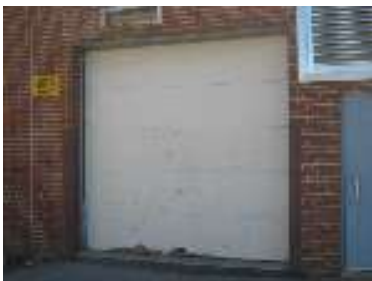
2012 - The wood overhead doors of the building are in poor overall condition, with peeling paint, physical damage, wood rot, wear and a generally aged appearance. The aluminum overhead door is in good condition.

August 2012 - Aged and deteriorated wood door observed

2012 - The wood overhead doors of the building have exceeded their expected useful life. The doors exhibit physical damage and are not functioning as intended. Based on age and observed condition, replacement is recommended.

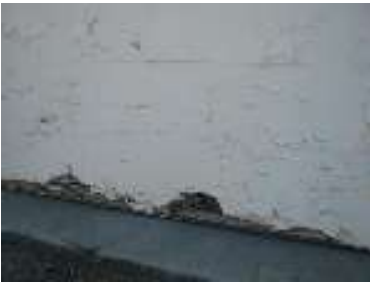
August 2012 - Wood rot and damaged door surface observed

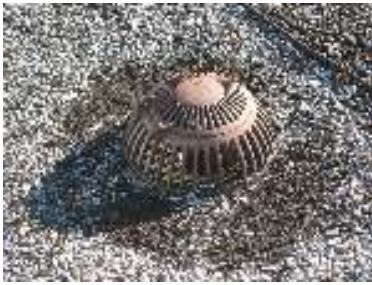
2012 - The condition of the roofing for Roof Sections 14, 15, 17 & 18 is consistent with its age and is in poor overall condition, with areas of repair, blueberry blisters, ridging, and corroded drain cover noted at the time of the assessment.

August 2012 - Appearance of corroded drain cover

2012 - The roofing for Roof Sections 14, 15, 17 & 18 has exceeded its expected useful life. Based on age and observed condition, replacement is recommended.

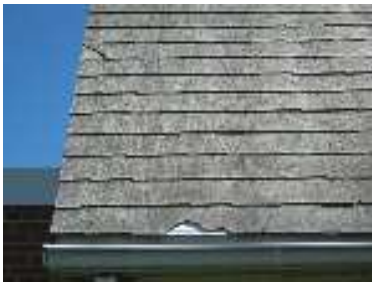
2012 - The asbestos shingles are generally in poor condition, with damaged and deteriorated shingles observed.

August 2012 - Damaged and deteriorated asbestos shingles observed

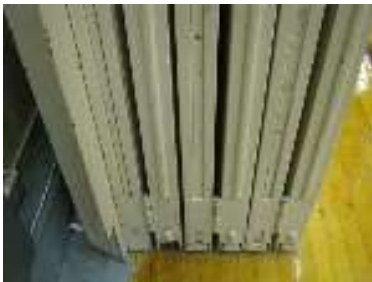
August 2012 - Deteriorated partitions observed

2012 - The moveable partition is approaching its expected useful life. Based on age and observed condition, replacement is recommended.

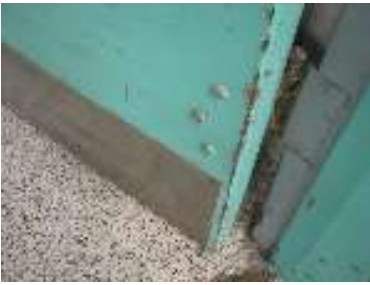
August 2012 - Worn and deteriorated butt hinge observed

2012 - The interior door hardware is approaching its expected useful life. Based on age and observed condition, replacement is recommended.

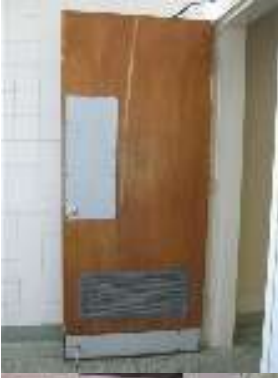
August 2012 - Laminate delamination observed

2012 - The interior doors of the building are approaching their expected useful life, are damaged. Based on age and observed condition, replacement is recommended.

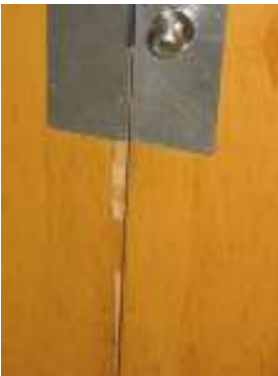
OLD\_View of damaged interior door.

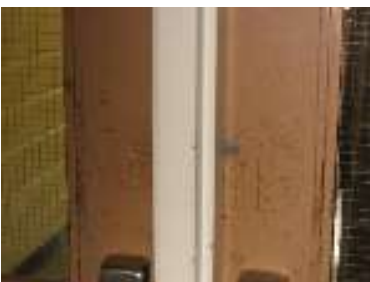
OLD\_View of corroding interior door.

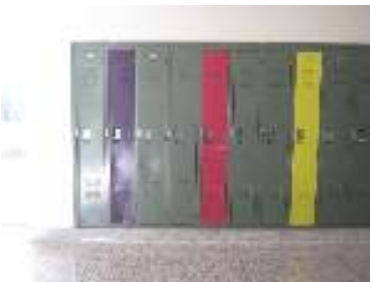
August 2012 - Aged and worn appearance of lockers

2012 - The student storage lockers are approaching their expected useful life. Based on age and observed condition, replacement is recommended.

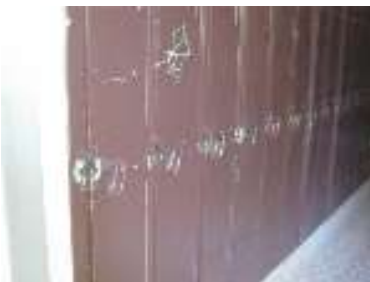
August 2012 - Faded paint and damaged surface of lockers observed

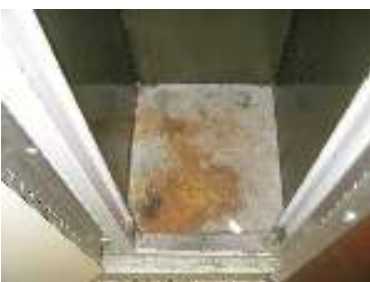
August 2012 - Corrosion at the bottom observed

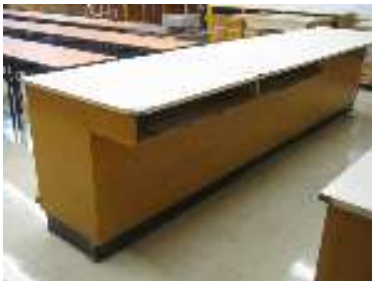
August 2012 - Damaged millwork observed

2012 - Approximately 30% of millwork in the building are approaching its expected useful life. Based on age and observed condition, replacement is recommended.

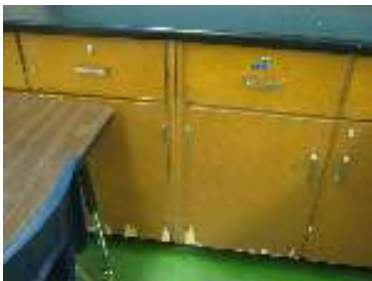
August 2012 - Laminate delamination observed

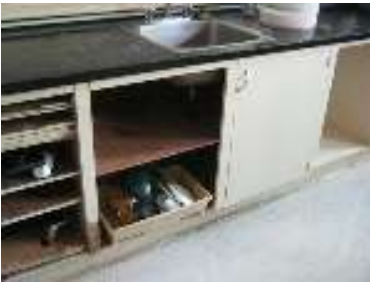
August 2012 - Aged and worn appearance of laboratory millwork

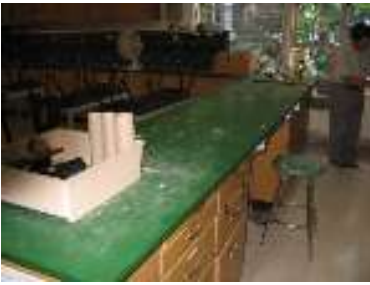
OLD\_View of stained laboratory countertops.

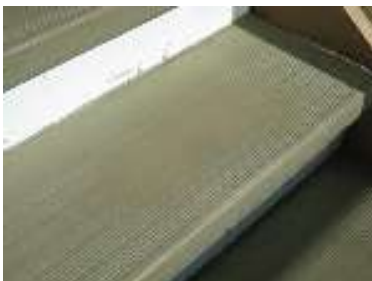
August 2012 - Worn and aged rubber treads observed

2012 - The metal framed interior stairs are approaching their expected useful life. Further deterioration of the stair framing and treads may result in loss of structural integrity as well as increase slipping and tripping hazards. Based on age and observed condition, replacement is recommended.

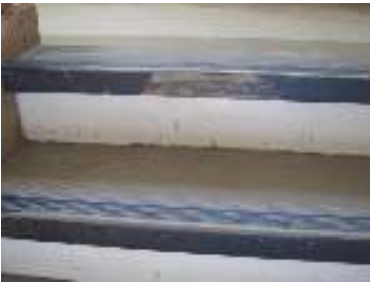
August 2012 - Damaged and deteriorated stair treads observed

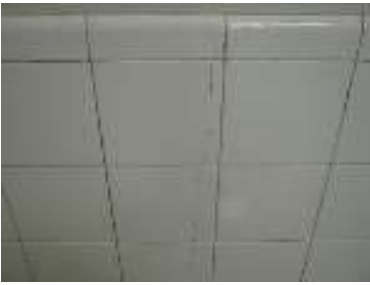
August 2012 - Cracked ceramic wall tiles observed

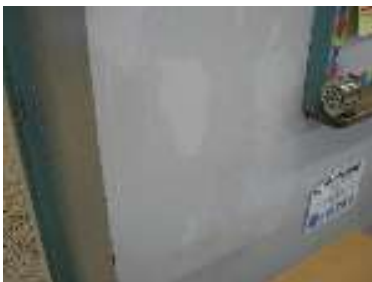
August 2012 - Stained and patched paint finish observed

2012 - Approximately 60% of paint wall covering has exceeded its expected useful life. Based on age and observed condition, replacement is recommended.

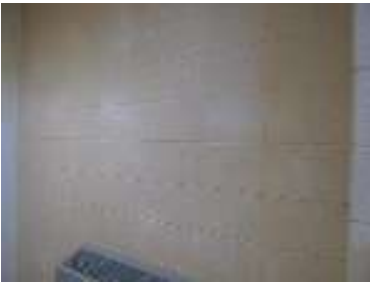
August 2012 - Faded paint wall covering observed

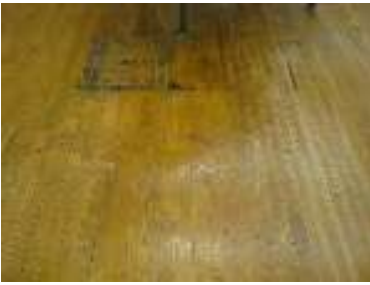
August 2012 - Stained and aged hardwood flooring observed

2012 - The hardwood flooring is beyond its expected useful life and exhibits wear typical of its age. Based on age and observed condition, replacement is recommended.

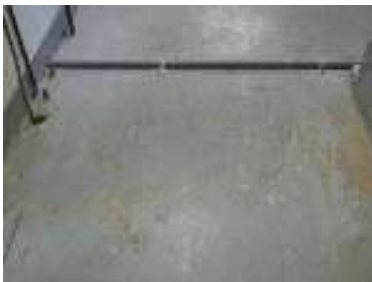
August 2012 - Excessive wear of painted concrete floor observed

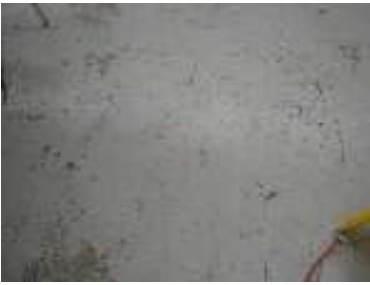
August 2012 - Damaged painted floor finish observed

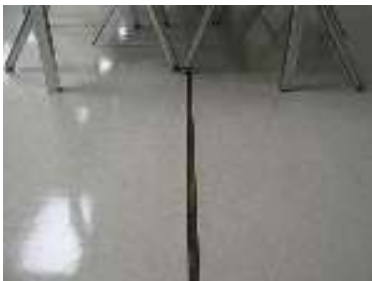
August 2012 - Debonded sheet vinyl flooring observed

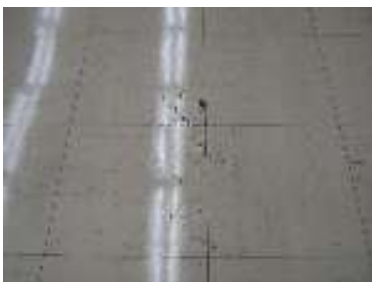
August 2012 - Damaged and deteriorated vinyl floor tiles observed

2012 - The majority of the vinyl tile flooring in the building is beyond its expected useful life, exhibiting wear and deterioration typical of its age. Based on age and observed condition, replacement is recommended.

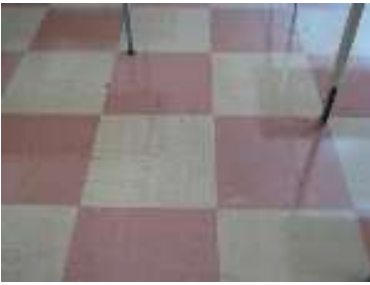
August 2012 - Aged and worn appearance of floor tiles

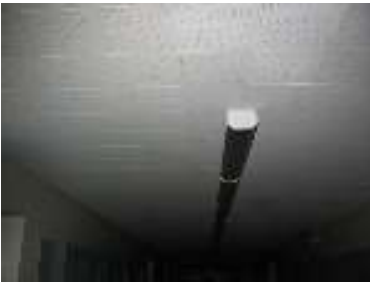
OLD\_View of damaged ceiling tile.

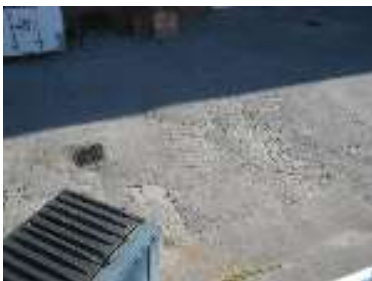
August 2012 - Heaved, cracked and uneven asphalt pavement observed

2012 - The asphalt pavement and associated concrete curbing of the driveway is beyond its expected useful life. Based on age and observed condition, replacement is recommended.

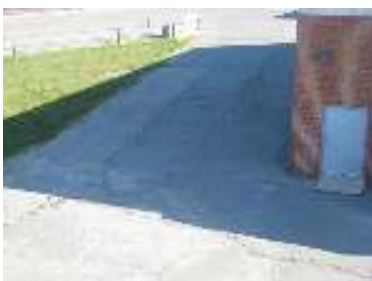
August 2012 - Longitudinal, transverse and alligator cracking observed

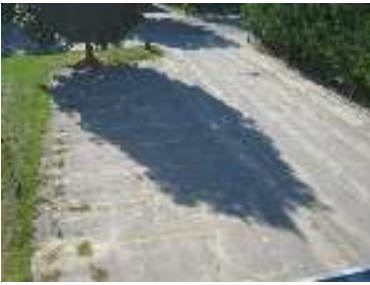
August 2012 - Ravelled and rutting observed on asphalt paved roadway

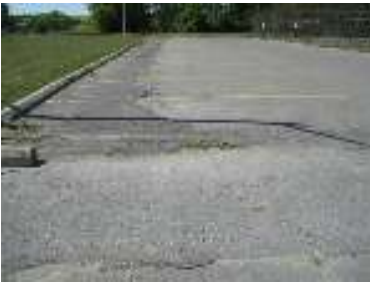
August 2012 - Uneven asphalt surface of parking lot

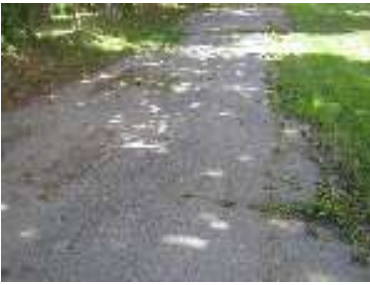
August 2012 - Vegetation growth on asphalt pavement observed

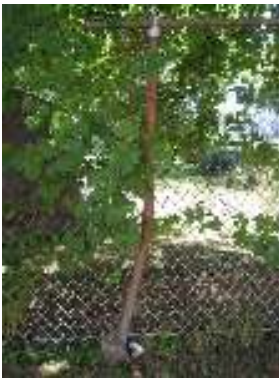
August 2012 - Damaged and deteriorated post observed

2012 - The chain-link fencing is beyond its expected useful life. Based on age and observed condition, replacement is recommended.

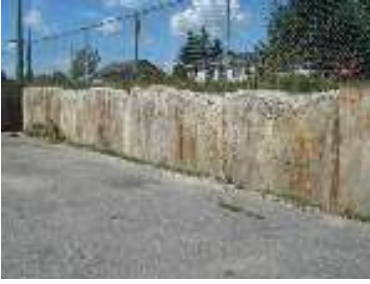
August 2012 - General view of cast-in-place concrete retaining wall

2012 - The cast-in-place concrete retaining wall has exceeded its expected useful life. Based on observed conditions, it appears the structural integrity of the wall is reduced and it is no longer functioning as intended. Replacement is recommended.

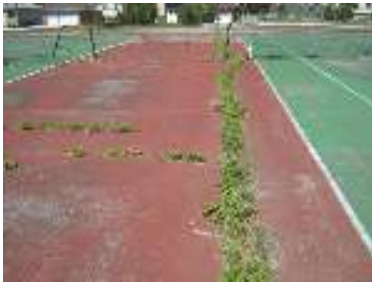
August 2012 - Vegetation growth observed

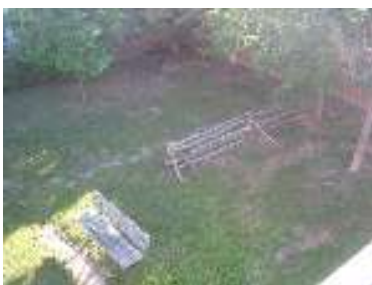
August 2012 - Poor graded ground observed

2012 - A storm water management study is recommended in order to determine the scope of the required remedial work to correct the drainage and ponding issues. The study should include repair options along with associated construction costs.

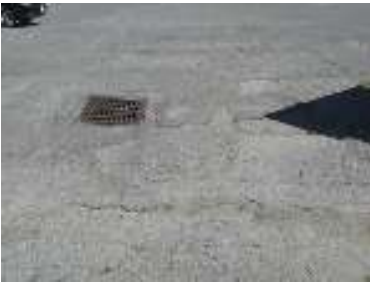
August 2012 - Catch basins in paved area and uneven asphalt pavement observed
