Hastings and Prince Edward District School Board

Condition Assessment

Queen Elizabeth School (Picton), Building ID 6529-1

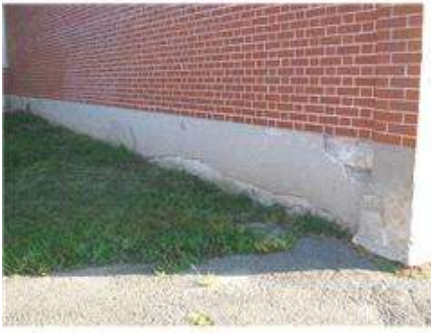
Condition Assessment 2012 - In general the building foundation walls appear to be performing as intended; however, several areas of the parging were noted to be cracked, spalled and delaminated.

August 2012 - Deteriorated parging noted

Recommendation 2012 - To minimize possible compromise of the poured concrete masonry foundation walls and to restore aesthetics, it is recommended that the parging be replaced.

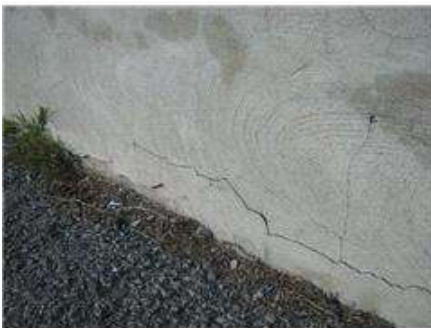
August 2012 - Cracked parging noted

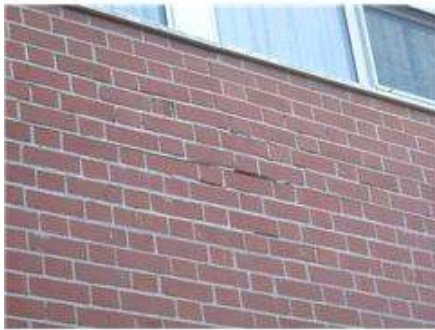
Condition Assessment 2012 - The mortar joints are in poor condition, with areas of deteriorated mortar noted and the brick wall system is in good overall condition.

August 2012 - Deteriorated mortar joints noted

2012 - Areas of deteriorating mortar were observed. In order to maintain the intended performance of the wall system, it is recommended to mortar repointing.

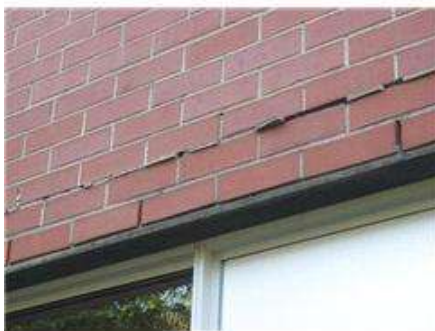
August 2012 - Missing mortar joint of exterior wall noted

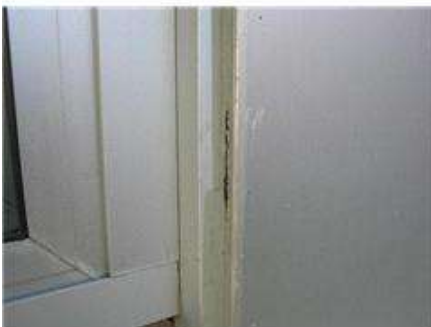
2012 - Sealant was observed to be in fair condition, with moderate loss of elasticity and instances of adhesive failure. The majority of the sealants appear to be well bonded.

August 2012 - Cracked window perimeter sealant noted

2012 – The sealant has exceeded its expected useful life. In order to maintain the performance of the building's exterior envelope, replacement of the sealant is recommended.

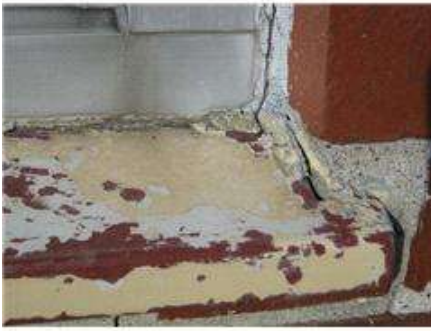
August 2012 - Deteriorated window perimeter sealant noted

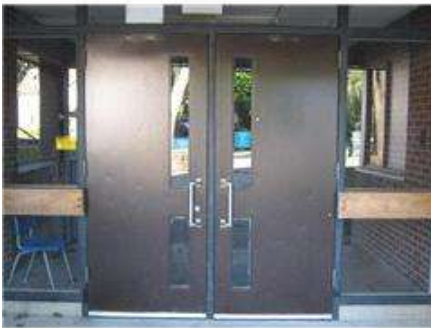
August 2012 - Physically damaged exterior door noted

2012 - The exterior hollow metal and aluminum doors and frames of the building are beyond their expected useful life. Based on age and observed condition, replacement of the exterior doors and frames is recommended.

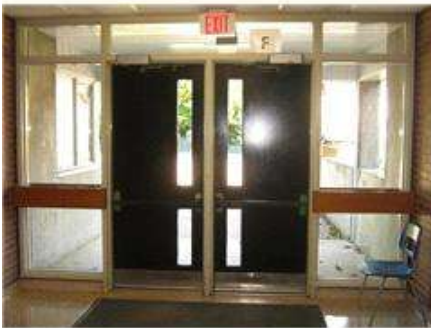
August 2012 - Aged exterior door noted

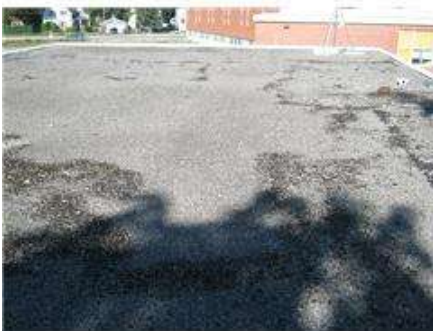
2012 - The condition of the roofing is consistent with its age and is in fair overall condition, with areas of blueberry blisters and ridges noted at the time of the assessment. No active roof leaks were reported at the time of the assessment.

August 2012 - Blueberry blisters noted on built-up roof

2012 - The roofing has exceeded its expected useful life. Based on age and observed condition, replacement is recommended.

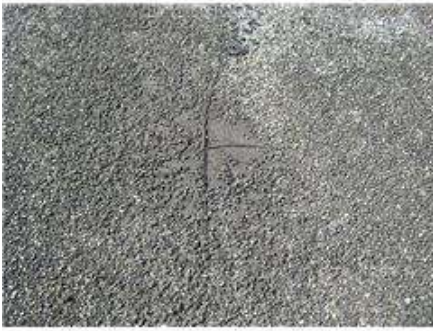
August 2012 - Riding of built-up roof noted

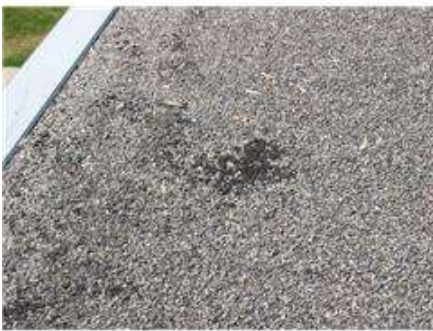
OLD_View of bleed through on the roof.

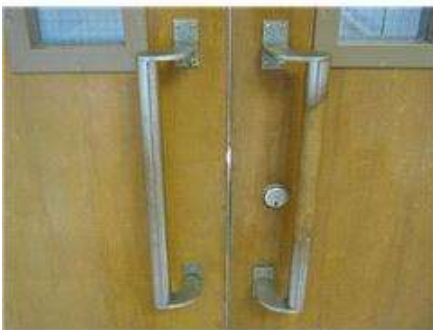
Condition Assessment 2012 - The interior door hardware in the building is in fair condition. The hardware is aged, worn and reportedly requires frequent maintenance and repair.

August 2012 - Worn interior door handles noted

Recommendation 2012 - The interior door hardware has exceeded its expected useful life. Based on age and observed condition, replacement is recommended.

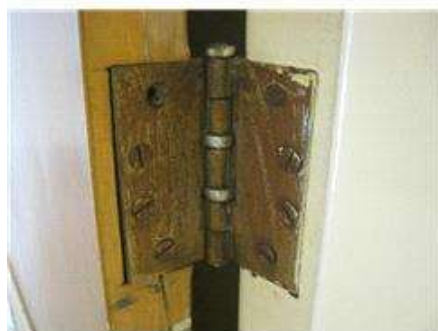
August 2012 - Corroded interior door hinge noted

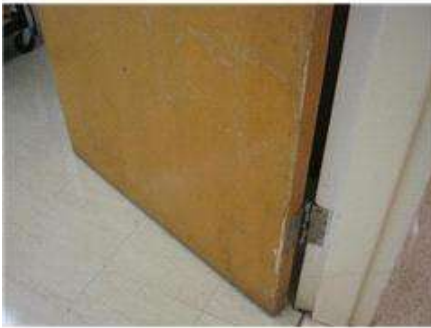
Condition Assessment 2012 - The interior doors appear to be original to construction and are in fair overall condition. The doors exhibit wear typical of their age, with scratched and delaminated door surfaces and a generally worn appearance. Some doors are impact damaged.

August 2012 - Worn and scratched interior wood door noted

Recommendation 2012 - The interior doors of the building have exceeded their expected useful life. Based on age and observed condition, replacement is recommended.

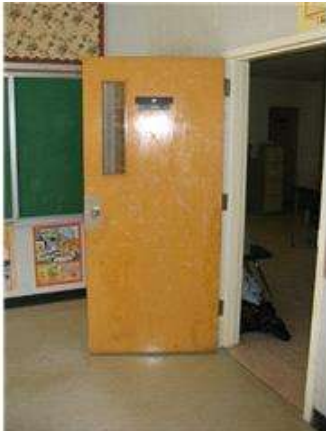
August 2012 - Damaged interior wood door noted

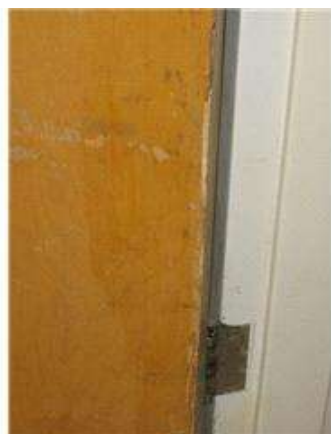
OLD_View of an interior door.

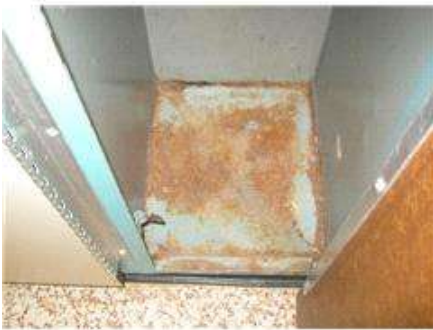
Condition Assessment 2012 - The student storage lockers are reportedly original to building construction and are in poor overall condition, with physical damage, corrosion and a generally aged appearance observed at the time of the assessment.

August 2012 - Corroded base of locker noted

Recommendation 2012 - The student storage lockers have exceeded their expected useful life. Based on age and observed condition, replacement is recommended.

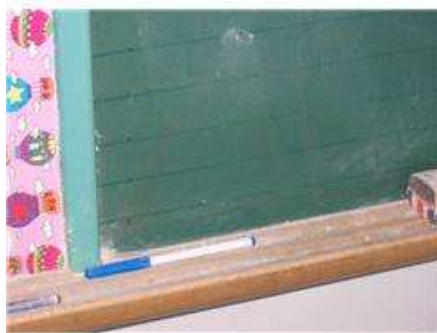
OLD_View of worn chalk tray.

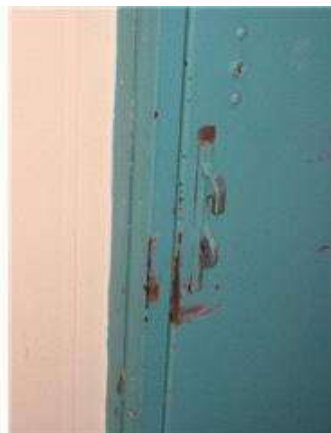
OLD_View of corrosion on the lockers.

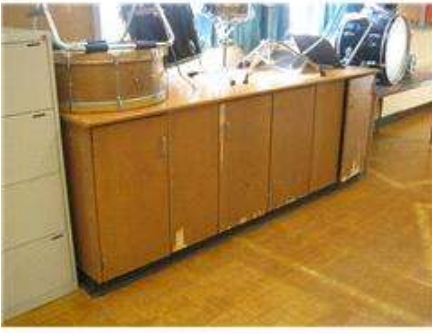
2012 - The millwork appears to be original to building construction and is in fair overall condition, with a generally aged appearance. Moderate wear and deterioration of the millwork were observed at the time of the assessment. Instances of broken millwork components were noted at the time of the assessment and the functionality of the millwork has been reduced as a result.

August 2012 - Damaged millwork noted

2012 - The millwork in the building has exceeded its expected useful life. Based on age and observed condition, replacement is recommended.

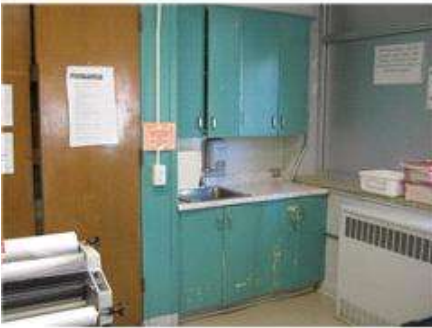
August 2012 - Poor performance of millwork noted

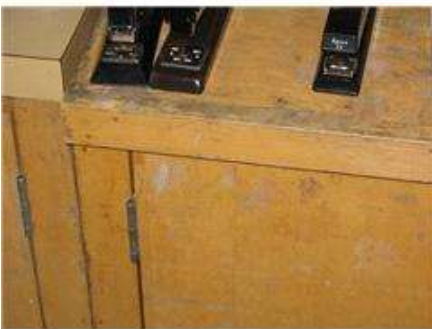
OLD_View of deteriorating millwork finish.

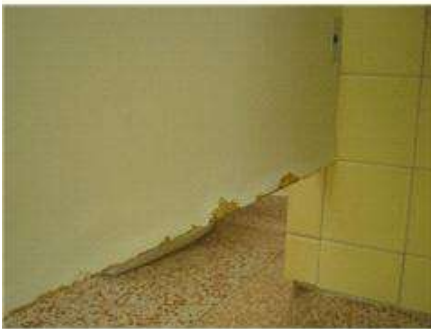
Condition Assessment 2012 - The washroom partitions are generally in fair condition, with delamination and a generally aged appearance observed.

August 2012 - Delaminated washroom partition noted

2012 - The washroom partitions are approaching their expected useful life. Based on age and observed condition, replacement is recommended.

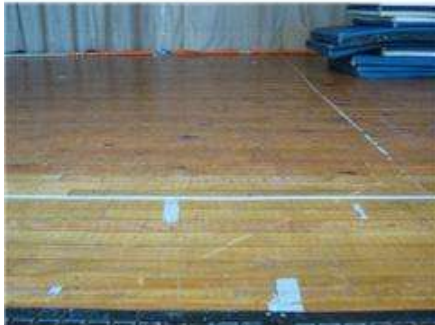
Condition Assessment 2012 – The hardwood flooring is in fair condition overall, with scratched, stained and worn areas observed.

August 2012 - Deteriorated hardwood floor of stage noted

2012 - The hardwood flooring is beyond its expected useful life. Based on age and observed condition, replacement is recommended.

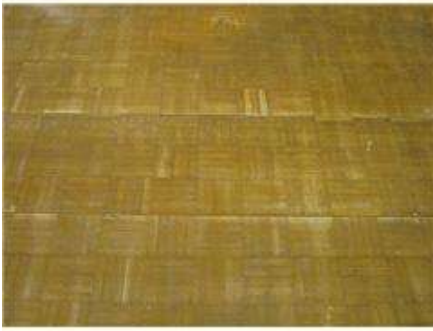
August 2012 - Debonded hardwood floor noted

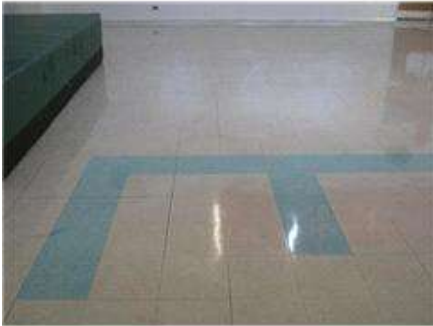
August 2012 - Debonded vinyl floor tiles noted

2012 - The majority of the vinyl tile flooring in the building has exceeded its expected useful life. Based on age and observed condition, replacement is recommended. The budget cost, which was calculated based on the provided designated substance report, includes abatement of the identified designated substance.

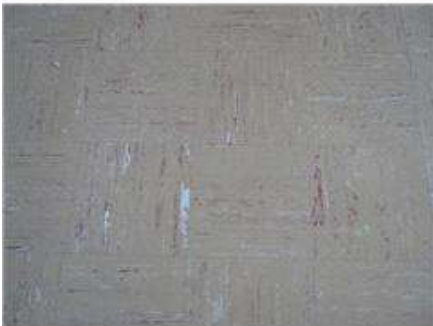
August 2012 - Worn vinyl floor tiles noted

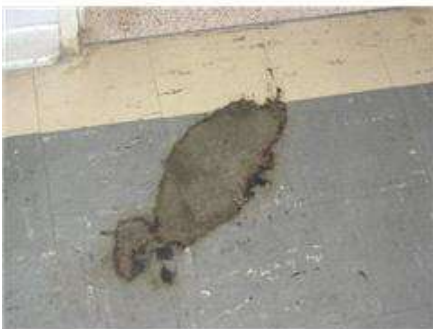
OLD_View of the worn vinyl floor tile.

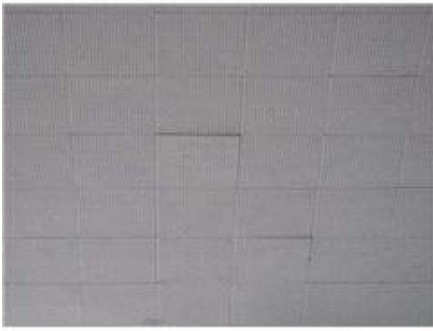
August 2012 - Debonded acoustic ceiling tiles noted

2012 - The fixed acoustic tile ceilings are beyond their expected useful life. Based on age and observed condition, replacement is recommended.

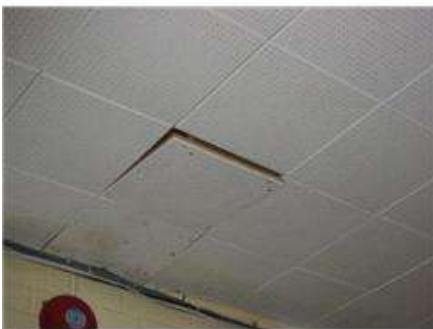
OLD_View of loose and damaged ceiling tiles.

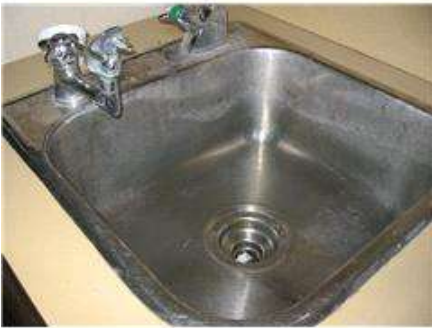
OLD_Stained sink and fixtures

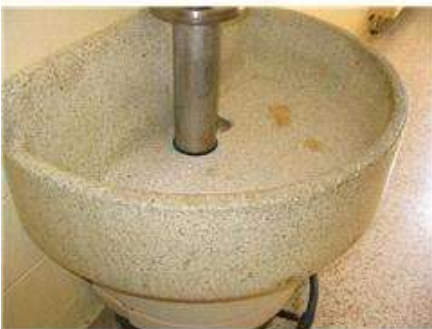
OLD_Stained and worn hand wash fountain

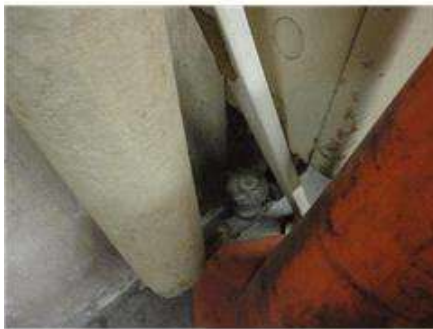
2012 - The plumbing piping system is mostly concealed and therefore its current condition is not fully known. With age, a plumbing piping system is known to develop pinhole leaks. Given its current age, an intrusive study is recommended to determine its condition.

August 2012 - Aged plumbing piping

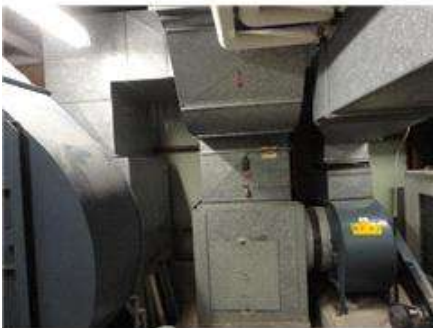
August 2012 - Aged duct system

Recommendation 2012 - In order to determine the condition and remaining expected useful life of the duct system, a study is recommended.

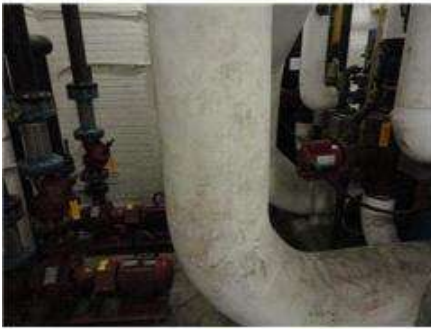
August 2012 - Aged heating piping

Recommendation 2012 - The heating piping system is known to develop pinhole leaks with age. In order to check the condition of the concealed heating piping system, an intrusive investigation is recommended.

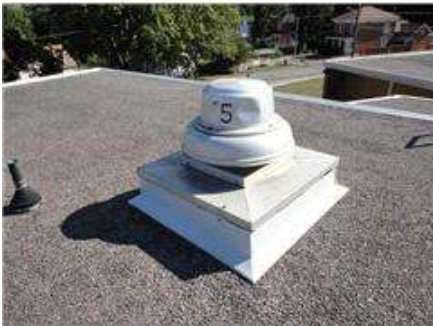
August 2012 - Aged exhaust fan

2012 - The exhaust fans have surpassed their expected useful life. Replacement of the aged exhaust fans is recommended to maintain indoor air quality.

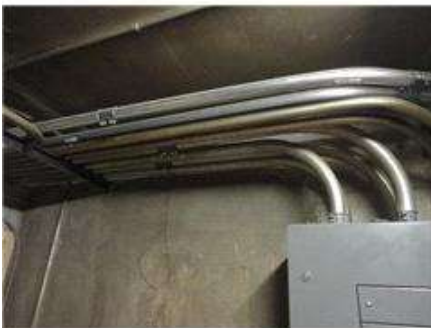
August 2012 - Aged branch wiring

Recommendation 2012 – The electrical wiring has exceeded its expected useful life. Over time, deterioration of the wire insulation and the conduit can occur. Some wiring may have been added or replaced but the extent of the modifications is not clear. Given the age of the electrical wiring, a study is recommended to determine the integrity of the wiring and to provide a scope and schedule of replacement.

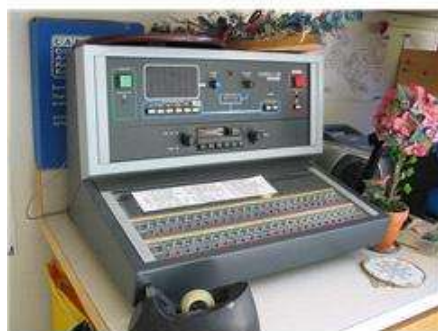
OLD_Communication console is obsolete

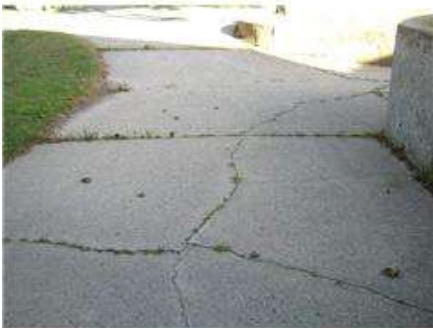
August 2012 - Cracked concrete paved walkway noted

Recommendation 2012 - The concrete paved walkways are beyond their expected useful life. Based on age and observed condition, replacement is recommended.

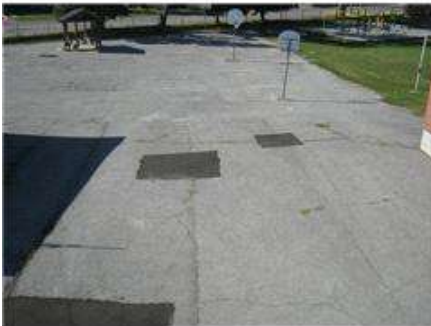
August 2012 - Cracked asphalt paved playground noted

2012 - The asphalt paved schoolyard is beyond its expected useful life. Based on age and observed condition, replacement of the asphalt is recommended.

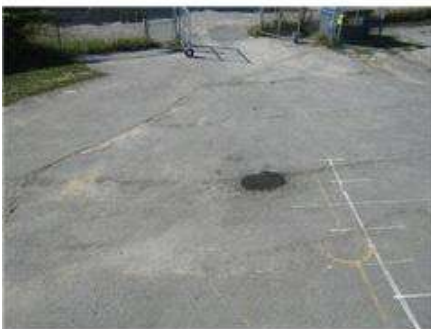
August 2012 - Ravelling noted on asphalt paved playground

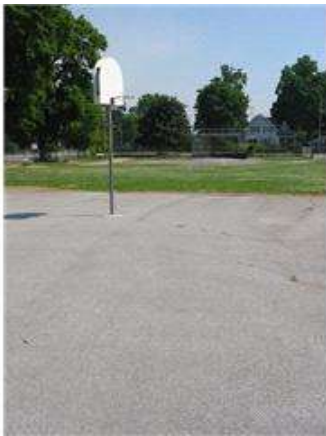
OLD_Overview of cracked asphalt.

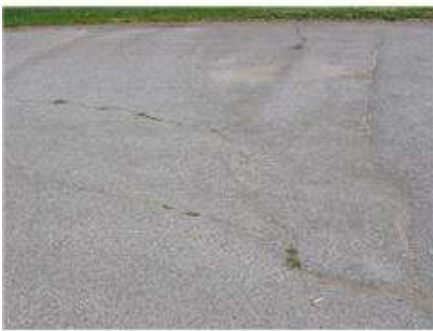
OLD_View of cracked asphalt on paved playground.
