**Hastings and Prince Edward District School Board**

**Condition Assessment**

**Sophiasburgh Central School, Building ID 5558-1**

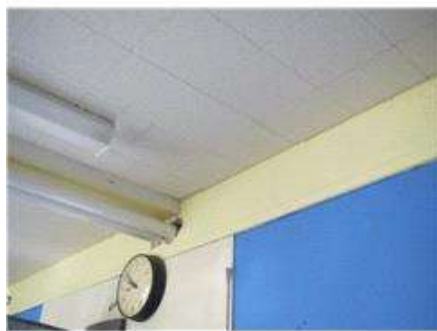
11/9/2013 4:11:10 PM Replacement - Structural Interior Walls - Fire stopping

**Description** 2013 – Missing fire stopping

**Condition Assessment** 2013 – At the time of the assessment there were numerous areas in the facility that lacked fire stopping, in both CMU wall system and in the GWB

**Recommendation** 2013 - The recommendation is perform the necessary addition for the fire stopping and it related construction repairs

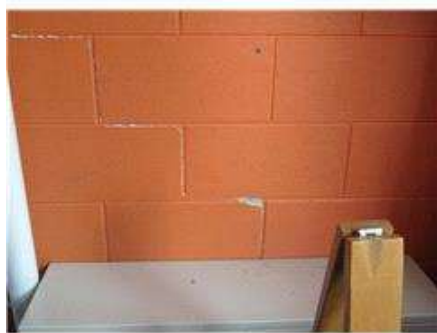
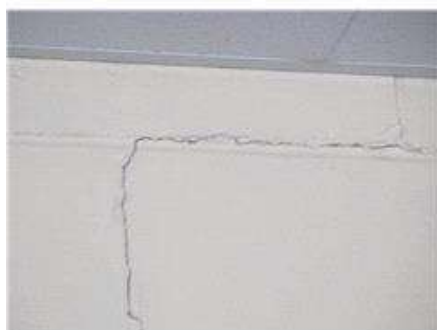
**Description** 2013 – Structural integrity – Step cracking in interior walls (CMU) and on the exterior brickwork (step cracks many times are an indication the footing under the foundation wall is moving.)

**Condition Assessment** 2013 - At the time of the assessment structural cracks were observed in many locations in the concrete masonry units

**Recommendation** 2013 - The recommendation is perform the necessary repairs based on the building consultants recommendations and estimate for the construction related repairs

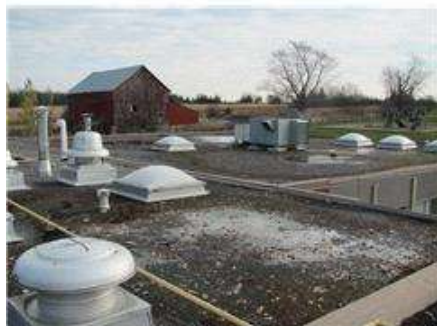
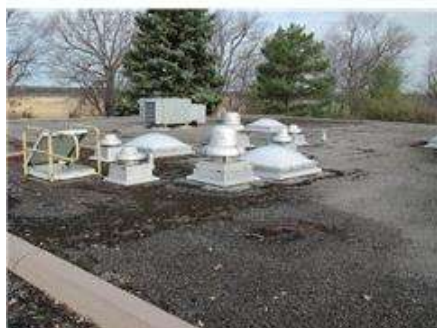
**Condition Assessment** 2013 - At the time of the assessment the BUR assembly is aged and worn with displaced ballast due to wind scouring and bleed through. Patches, ridges, deteriorated flexible flashings with open joints, and pitch pockets with brittle sealant were deficiencies noted.

2013 - The aggregate-surfaced built up roof (BUR) assembly system on the original roof is approaching its expected service life, but continues to perform as intended. Replacement is anticipated in 2016.

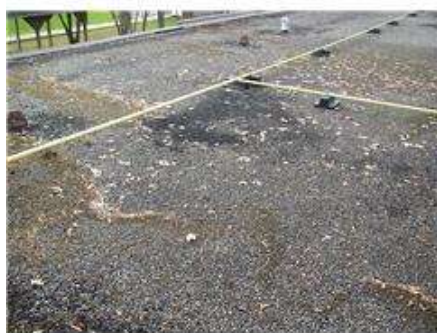
1/9/2013 Replacement B3010 Roof Coverings - Original Building - Section 2

2013 - At the time of the assessment the BUR assembly is aged and worn with displaced ballast due to wind scouring and bleed through. Patches, ridges, deteriorated flexible flashings with open joints, and pitch pockets with brittle sealant were deficiencies noted.

2013 - The aggregate-surfaced built up roof (BUR) assembly system on the original roof is approaching its expected service life, but continues to perform as intended. Replacement is anticipated in 2016.

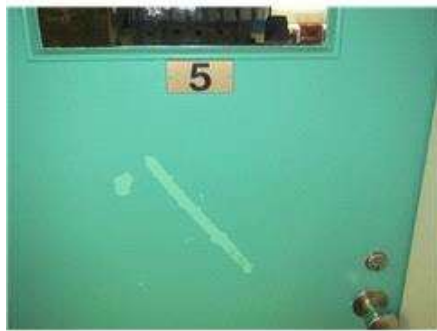
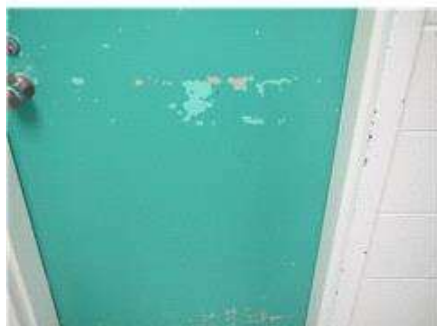
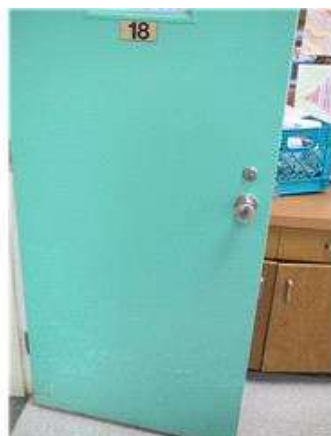
2013 – The interior doors appear to be original to construction and are in fair condition overall. The doors exhibit wear typical of their age, with scratched and delaminated door surfaces and a generally worn appearance. Some doors are damaged.

2013 – The interior doors of the building have exceeded their expected useful life, are worn and are aesthetically displeasing. Based on age and observed condition, replacement is recommended.

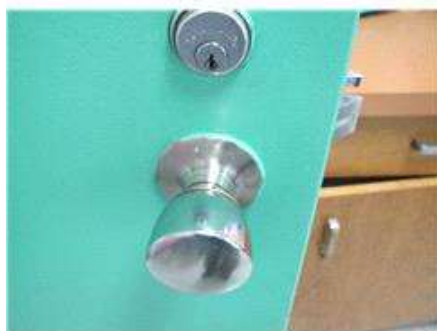
11/28/2013 Replacement of interior door hardware

**Condition Assessment** 2013 - At the time of the assessment the interior door hardware was observed to be aged, worn and deteriorated. Corrosion was noted on various components.

**Recommendation** 2013 - The interior door hardware is of the same vintage as the interior door. Replacement of the door hardware along with the interior doors is suggested.

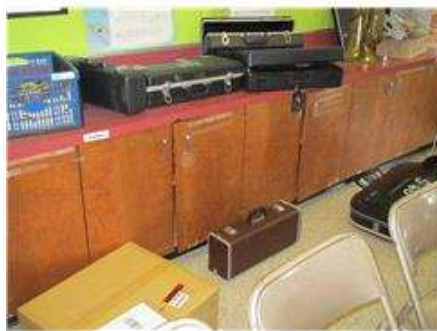
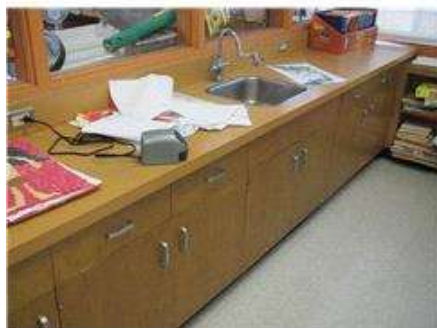
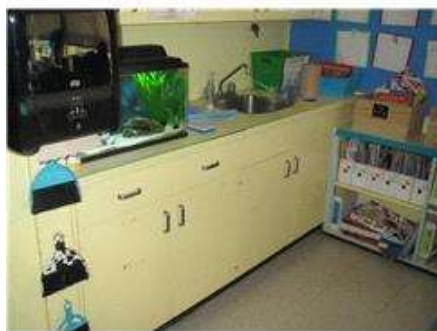
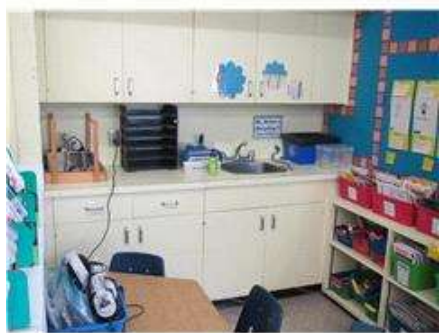
2013 - At the time of the assessment, the original painted and veneer millwork was observed to have exceeded its effective rated design life. The millwork is in fair - poor condition based on its age with signs of routine refinishing and countertop replacements, which have extended its useful life.

2013 - The millwork has exceeded its theoretical life. Periodic painting has minimized delaminating of substrate and deterioration, which was evident. Replacement based on age and condition is recommended

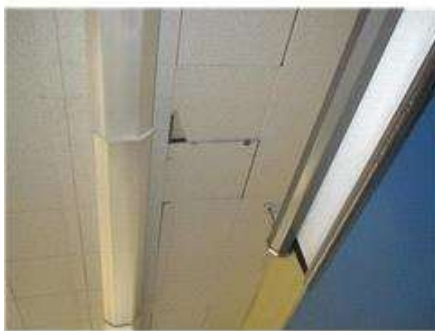
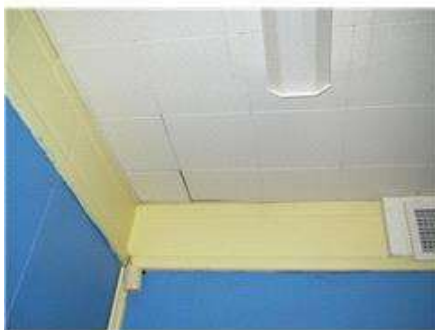
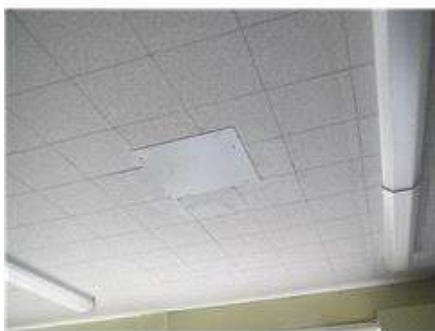
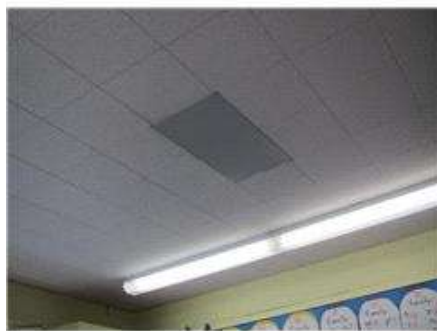
**Condition Assessment** 2013 - At the time of the assessment the fixed acoustic tile ceilings is in fair overall condition, with debonded tiles observed.

**Recommendation** 2013 - The fixed acoustic tile ceilings are beyond their expected useful life. Based on age and observed condition, replacement is recommended.

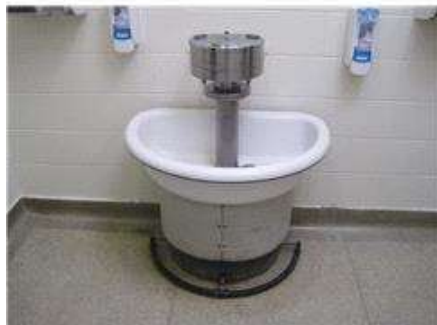
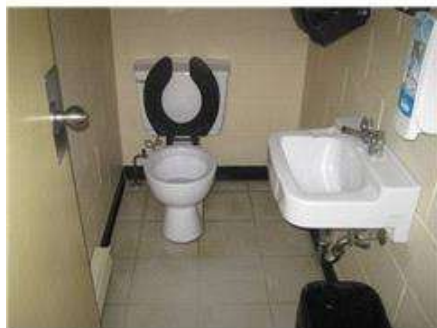
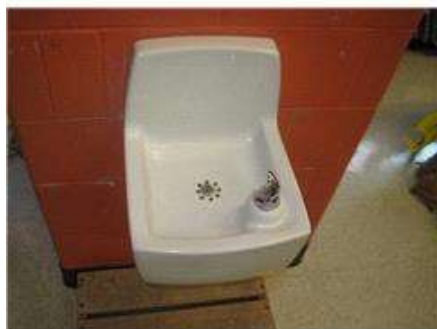
**Condition Assessment** 2013 – The majority of the plumbing fixtures are from 1965 and 1968 and appear to be functioning but in poor condition. Some fixtures have been replaced over time. The majority of fixtures have surpassed the end of their normal service life. Planning for renewal is recommended.

2013 - The installation of plumbing fixtures appears to be original to the building construction. The fixtures are aged and in poor shape. Corrosion, staining and damage was noted on the fixtures. The replacement of outdated fixtures is recommended.

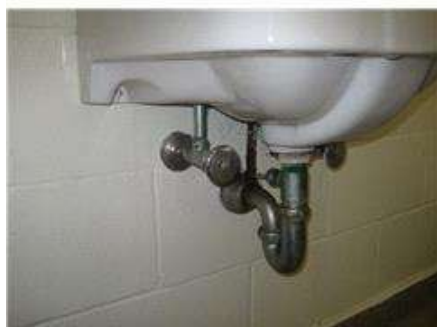
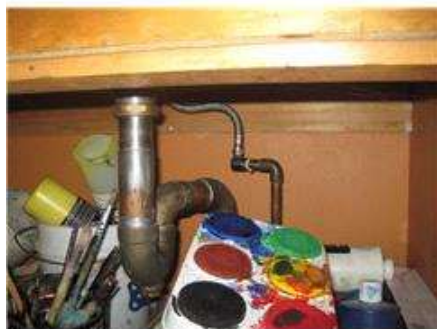
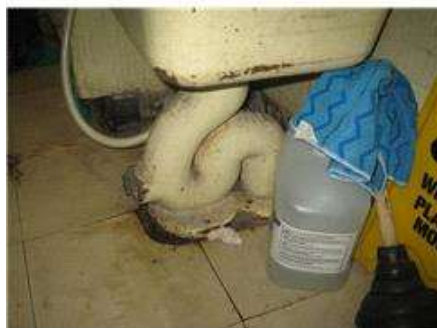
2013 - The plumbing piping system is mostly concealed and therefore the current condition is not fully known. Due to age and heavy use, piping has signs of corrosion and deterioration. However, an intrusive study is recommended to determine the condition of the plumbing piping system and the recommended scope of work and the cost for system renewal.

2013 - Plumbing piping has exceeded its theoretical service life; however, condition cannot be fully determined. Replacement is subject to results of proposed study to determine current condition. Cost and schedule of replacement to be determined by study. Deferral may result in poor functioning or leaking of plumbing pipes, likely causing damage to other building components.

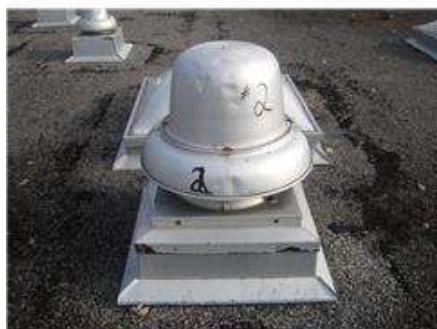
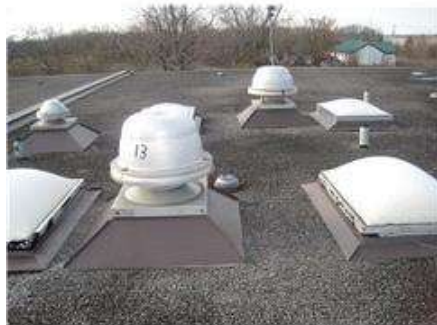
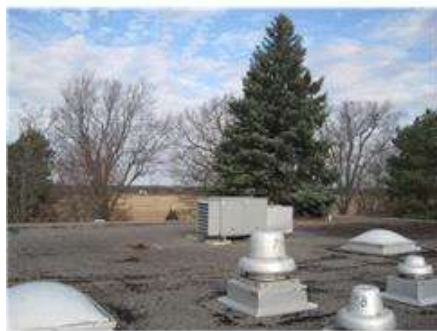
**Condition Assessment** 2013 - The exhaust fans are typically original to the building. Many fans have damaged casing and many were vibrating excessively. The fans are in poor condition overall.

2013 - The exhaust fans are operating but have passed their expected useful lives and will likely require replacement in the short term as many are in poor condition.

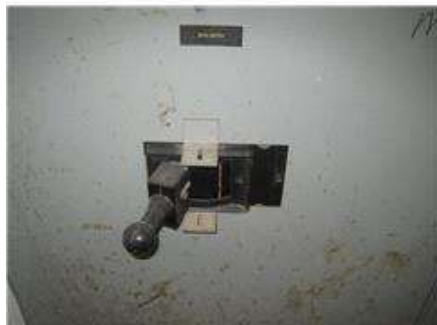
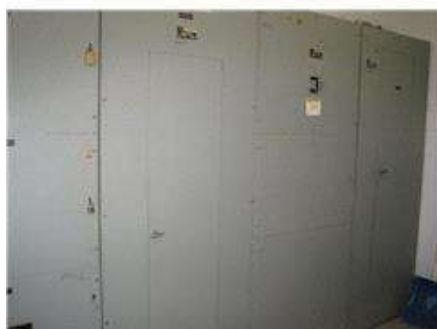
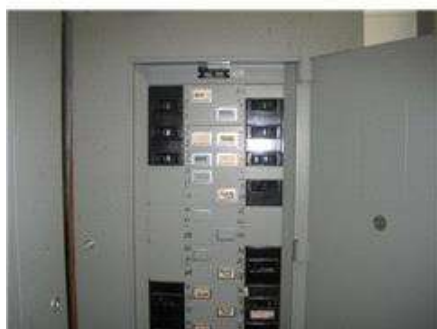
**Condition Assessment** 2013 – The original main service switchboard including panel assemblies, main distribution panel, breaker, fuses and meters has exceeded the rated useful life and should be replaced due to age and reliability.

2013 – Replace the aged switchboard and other assemblies including main distribution panel, breaker, fuses and meters of the building

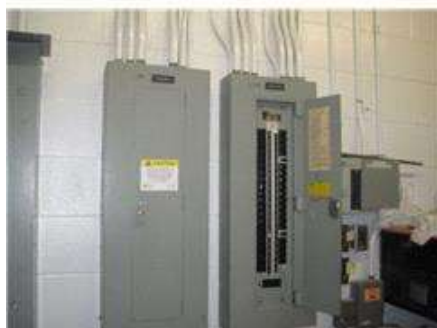
11/5/2013 9:47:42 PM Replacement [D501005 Panels - Original Building & Addition 1]

**Condition Assessment** 2013 – The original distribution equipment including panel assemblies, main distribution panel, breaker, fuses and meters have exceeded the rated useful life and should be replaced due to age and reliability.

**Recommendation** 2013 – Replace the aged switchboard and other assemblies including main distribution panel, breaker, fuses and meters of the building.

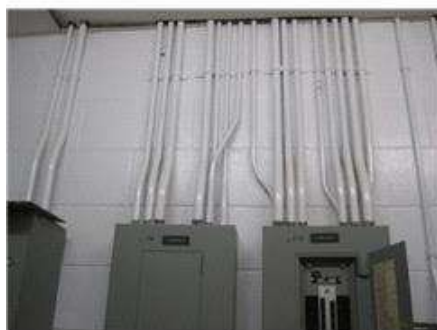
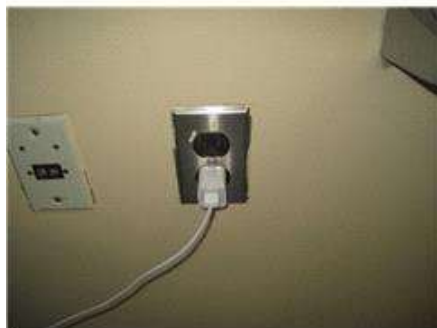
2013 – The switches, outlets, panels, and wiring throughout the building are outdated and inadequate. They have surpassed their theoretical life and exceeded the maximum capacity, replacement of these components is recommended. Replace cabling, raceways, bus ducts and breaker panels based on age, useful life and existing capacity. Cost provided is an estimate; a more accurate cost will depend on the evaluation study.
