**Hastings and Prince Edward District School Board**

**Condition Assessment**

**C M L Snider School, Building ID 5630-1**

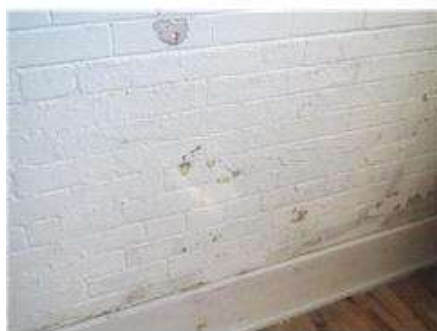
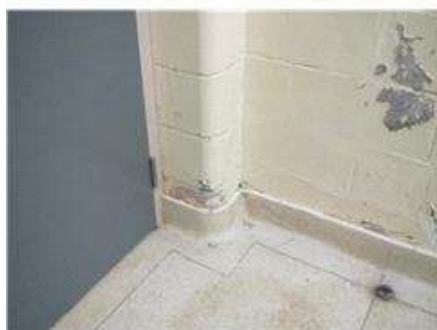
**Description** 2013 –In the lower level of the facility there are several areas showing signs of moisture penetration

**Condition Assessment** 2013 – At the time of the assessment it was observed in various locations in the lower level of the facility that several areas were showing signs of moisture penetration through the brick and CMU

**Technical Condition** Poor

**Recommendation** 2013 - Repair as directed by the findings of the study should be undertaken to minimize further water infiltration and subsequent deterioration. The repair cost provided is for budgeting purposes only and should be confirmed in the recommended study.

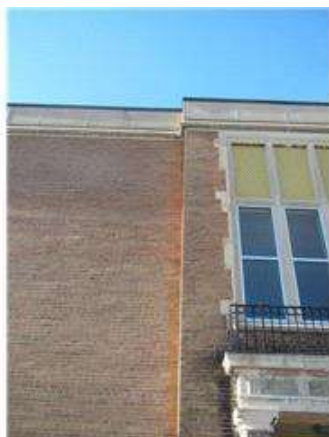
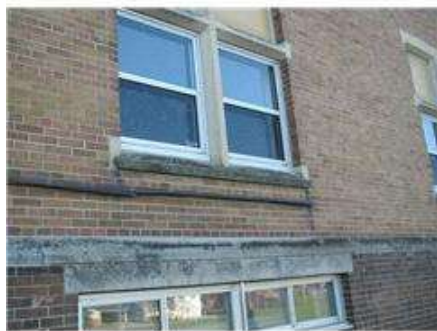
**Description** 2013 - The walls were observed to consist of exterior brick veneer wall and concrete masonry backup walls.

**Condition Assessment** 2013 – At the time of the assessment the exterior brickwork was observed to be in need of repairs, there was obvious signs of mortar loss, miss matched bricks and the concrete window sills were showing signs of moisture damage

**Technical Condition** Poor

**Recommendation** 2013 – Based on the observed condition it is recommend that brick repairs be carried out as soon as possible, these being repointing and brick replacement where necessary to maintain the integrity of the building envelope and cleaning of the original exterior building brick and concrete sills to remove organic growth. The repair cost provided is for budgeting purposes only and should be confirmed in the recommended study

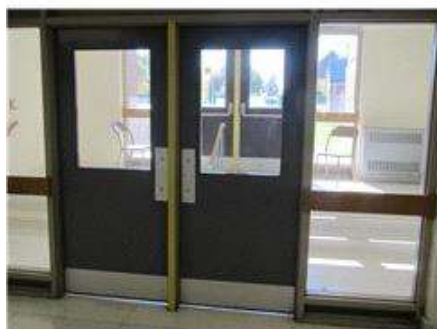
**Condition Assessment** 2013 - At the time of the assessment the exterior doors were in fair condition, rusting, signs of deterioration on frames

**Technical Condition** Fair

**Recommendation** 2013 - The exterior doors have surpassed there operational use, they are in fair condition, it is recommend they should be replaced

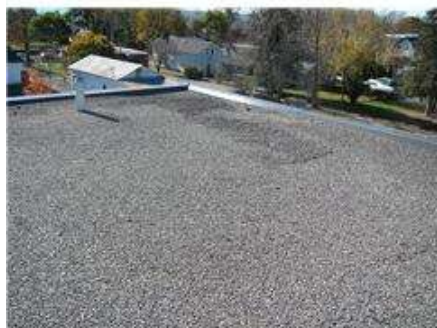
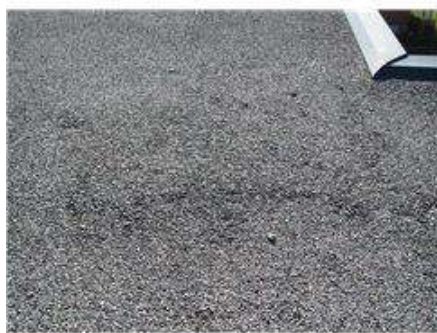
2013 - At the time of the assessment the condition of the assembly system of the roof sections is consistent with its age and is in fair/poor overall condition. No roof leaks have been reported to date.

2013 - Based on the observed condition roofing repairs should be carried to maintain the roof covering integrity and there expected useful life, the recommendation is for repairs right now

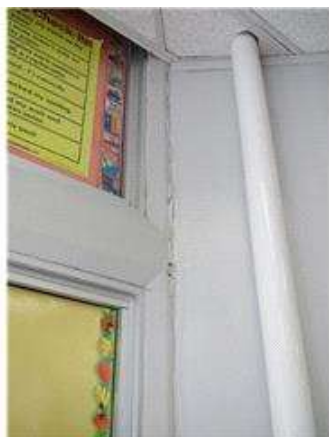
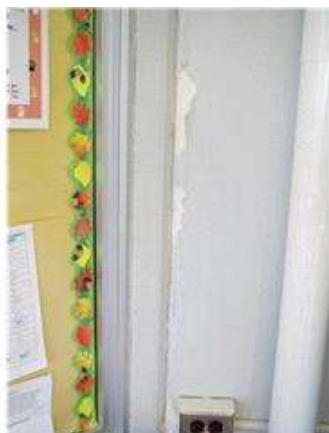
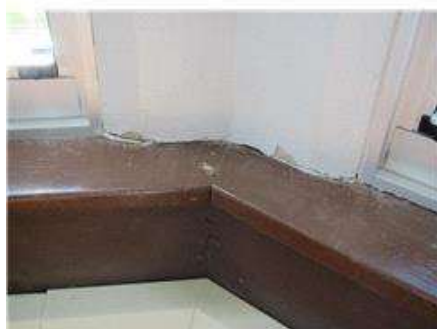
**Description** 2013 – Interior classroom wall condition – moisture damage on the plaster / GWB

**Condition Assessment** 2013 – At the time of the assessment it was observed in several of the #300 classrooms moisture damage on the plaster / GWB around the windows. It appears that the moisture is entering either through the brickwork or the windows.

**Technical Condition** Poor

2013 – Based on the observations and comments made by the board representative it is recommended that a building envelope study be carried out by retaining a building consultant be retained to determine what - where - and the costs for repairs might be.

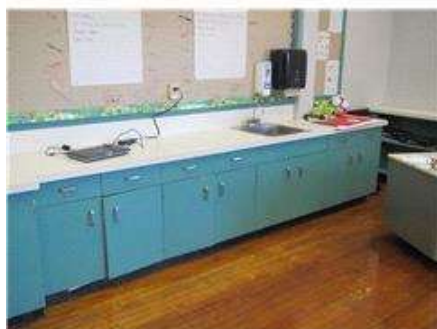
2013 - At the time of the assessment, the original painted and veneer millwork was observed to have exceeded its effective rated design life. The millwork is in fair - poor condition based on its age with signs of routine refinishing and countertop replacements, which have extended its useful life.

2013 - The millwork has exceeded its theoretical life. Periodic painting has minimized delaminating of substrate and deterioration, which was evident. Replacement based on age and condition is recommended

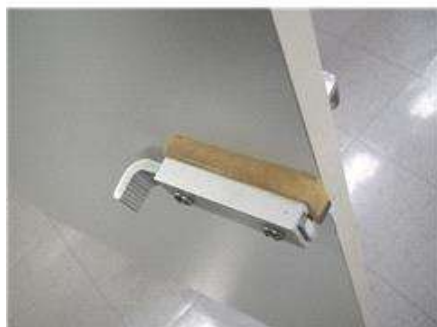
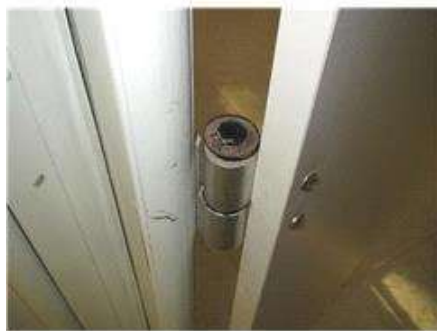
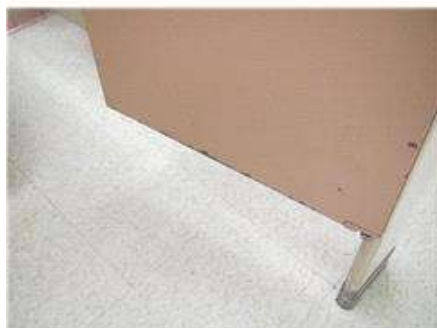
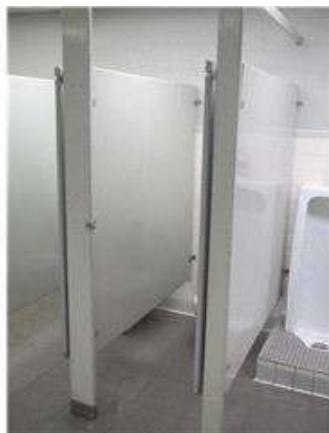
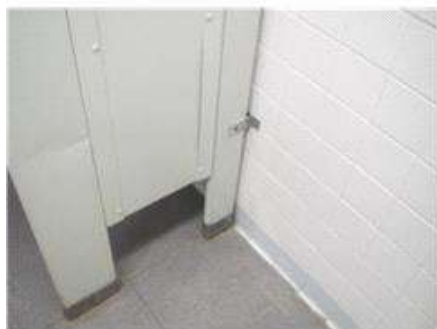
**Description** 2013 - Boys and girls washrooms were observed to be provided with hollow metal partitions.

**Condition Assessment** 2013 - At the time of the assessment the metal washroom partitions were observed to be aged worn and deteriorated, with corrosion of panels.

**Recommendation** 2013 - The metal washroom partitions were observed to be aged worn and deteriorated, with corrosion of panels. Replacement is suggested.

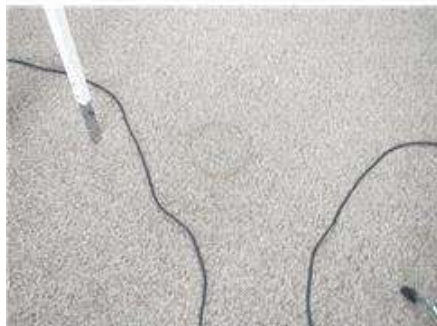
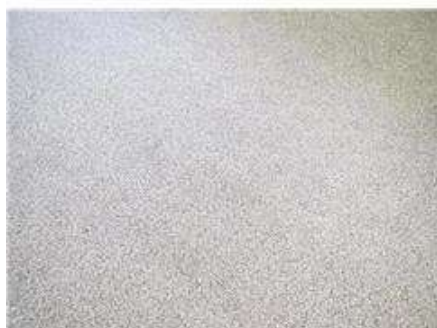
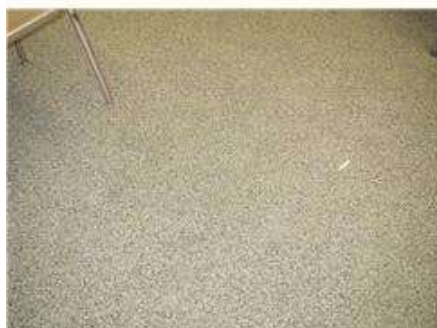
**Condition Assessment** 2013 – At the time of the assessment the commercial grade carpet in music room #101 was in a fair to poor condition, staining was visible and there were obvious signs of age also

2013 - The carpet flooring is beyond its expected useful life. Based on age and observed condition, replacement is recommended.

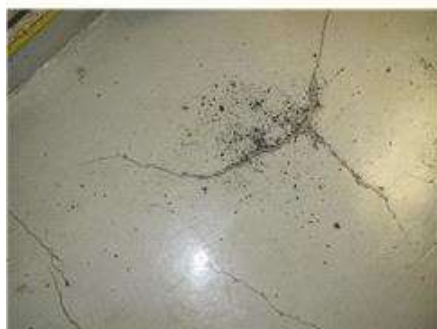
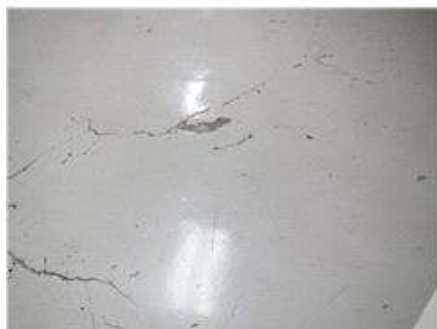
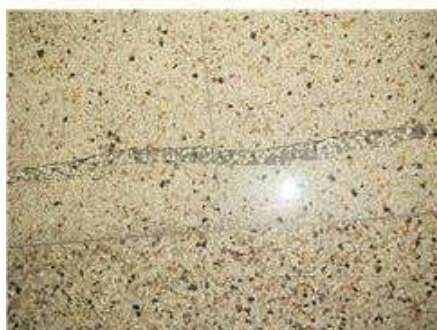
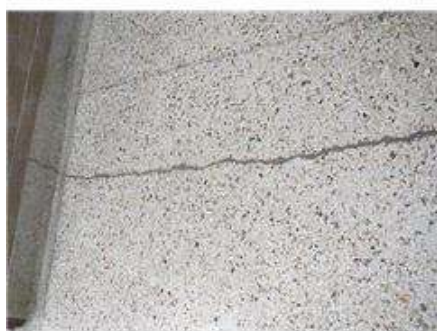
2013 - At the time of the assessment it was observed that the terrazzo flooring has structural cracking

2013 - Due the age of the facility and the number structural cracks in the terrazzo flooring it is recommended that a study be carried to determine the possible causes of such cracks and prepare an estimate for the necessary repairs.

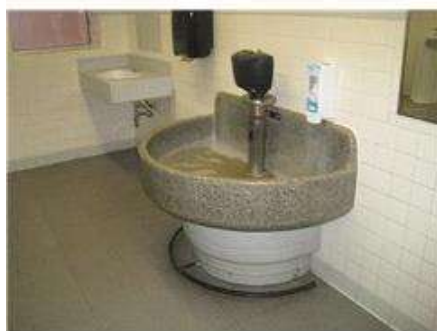
**Condition Assessment** 2013 – The plumbing fixtures in the basement are from 1967 and appear to be functioning but in poor condition. Majority of fixtures have been replaced over time and in good condition.

**Recommendation** 2013 - The installation of plumbing fixtures appears to be original to the building construction in the basement. The fixtures are aged and in poor shape. Corrosion, staining and damage was noted on the fixtures. The replacement of outdated fixtures is recommended.

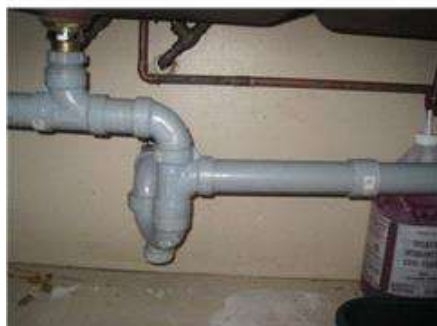
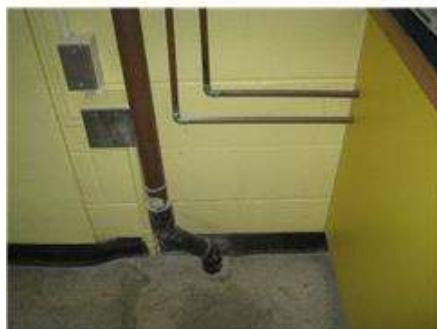
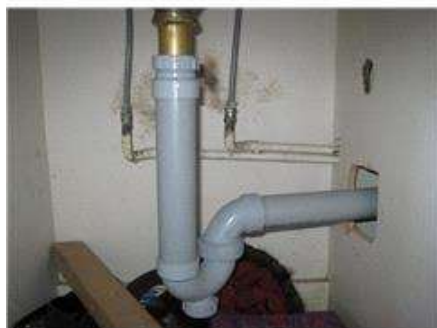
2013 - The plumbing piping system is mostly concealed and therefore the current condition is not fully known. Due to age and heavy use, piping has signs of corrosion and deterioration. However, an intrusive study is recommended to determine the condition of the plumbing piping system and the recommended scope of work and the cost for system renewal.

2013 - Plumbing piping has exceeded its theoretical service life; replacement of the plumbing piping system is recommended. Deferral may result in poor functioning or leaking of plumbing pipes, likely causing damage to other building components.

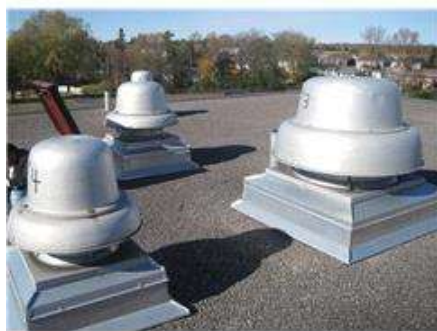
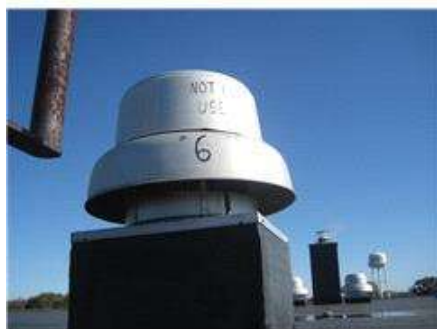
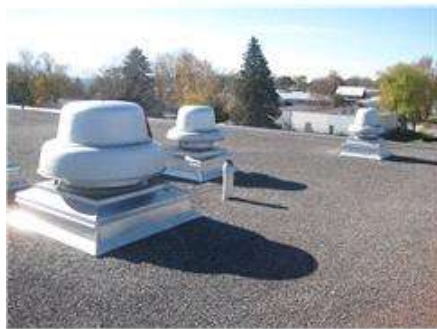
**Condition Assessment** 2013 - The exhaust fans are typically original to the building. Many fans have damaged casing and many were vibrating excessively. The fans are in poor condition overall.

2013 - The exhaust fans are operating past their expected useful lives and will likely require replacement in the short term as many are in poor condition.
