Hastings and Prince Edward District School Board

Condition Assessment

Kente Public School, Building ID 6095-1

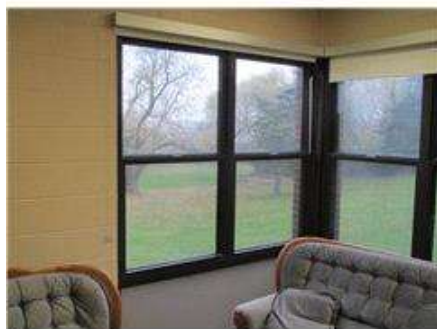
Condition Assessment 2013 - At the time of the assessment the building windows are in fair/poor overall condition, with an aged appearance, deteriorating seals and reported water and air infiltration. Water staining was noted on interior window sills, verifying the occurrence of water leakage.

Recommendation 2013 - The windows of the building are beyond their expected service life. Based on the windows performance and observed condition, age, design and thermal properties, replacement of the building windows is recommended.

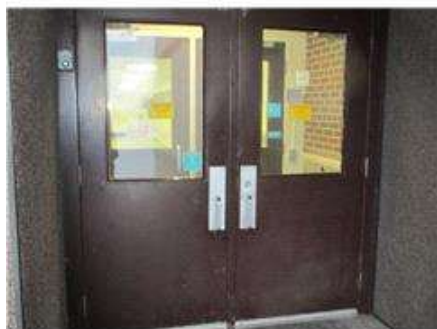
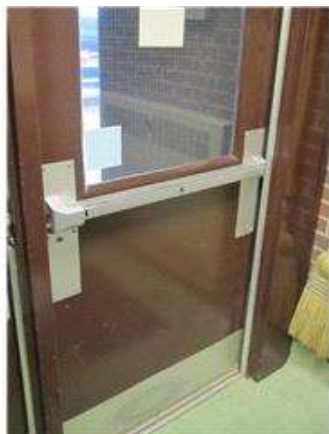
Condition Assessment 2013 - At the time of the assessment the exterior door assemblies were observed to be original, with worn finish, damaged frames, deteriorated door seals, single glazed georgian wired glass and hardware have exceeded their useful design rated life.

Recommendation 2013 - The exterior door assemblies and hardware are original, aged and worn beyond useful design rated life. Replacement of the door assemblies and hardware is suggested.

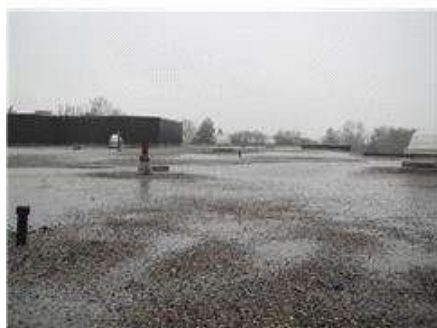
2013 - At the time of the assessment the condition of the aggregate-surfaced built up roof (BUR) assembly system on the original roof is consistent with its age and is in fair - poor condition overall.

2013 - The aggregate-surfaced built up roof (BUR) assembly system on the roof has approached its expected service life, but continues to perform as intended. Replacement is anticipated in 2016.

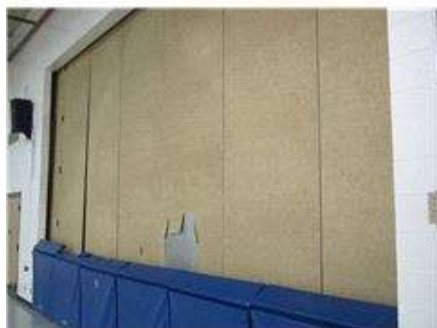
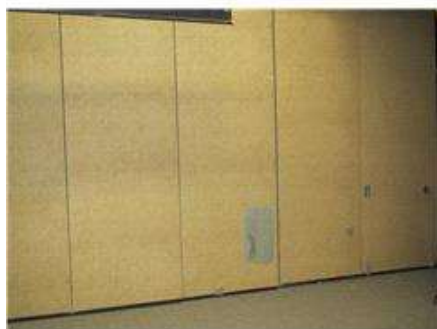
Condition Assessment 2013 - At the time of the assessment the retractable folding partition condition was fair to poor condition; coverings on the moveable partition are damaged and generally deteriorated.

Recommendation 2013 - Based on the retractable folding partitions observed condition. Replacement is recommended.

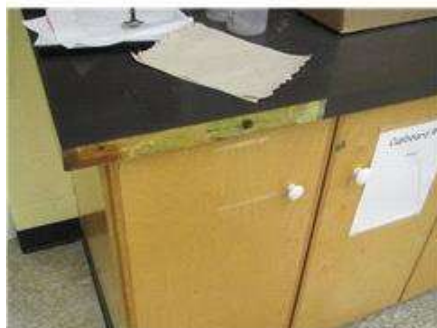
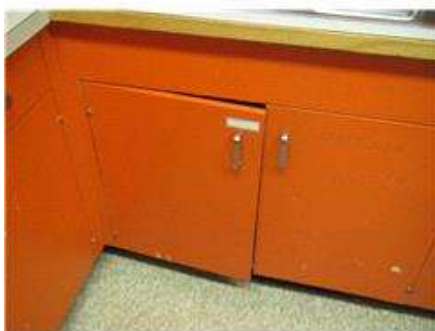
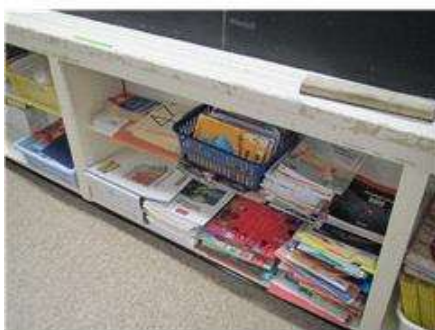
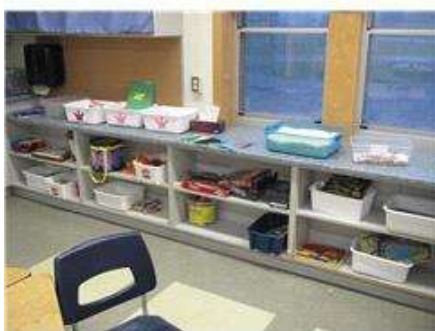
2013 - At the time of the assessment, the original painted and veneer millwork was observed to have exceeded its effective rated design life. The millwork is in fair - poor condition based on its age with signs of routine refinishing and countertop replacements, which have extended its useful life.

2013 - The millwork has exceeded its theoretical life. Periodic painting has minimized delaminating of substrate and deterioration, which was evident. Replacement based on age and condition is recommended

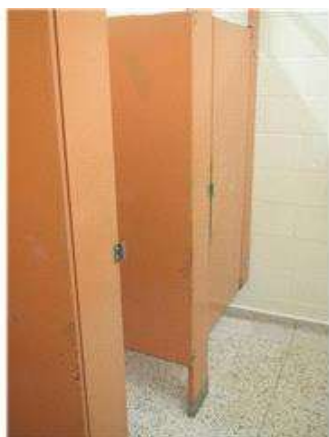
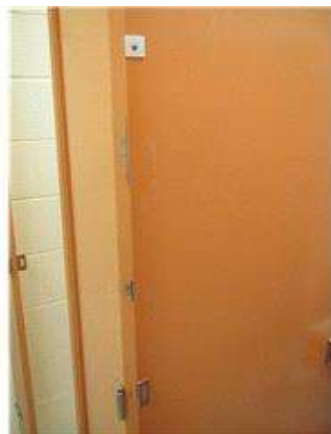
2013 - At the time of the assessment the metal washroom partitions were observed to be aged worn and deteriorated, with corrosion of panels.

2013 - The metal washroom partitions were observed to be aged worn and deteriorated, with corrosion of panels. Replacement is suggested.

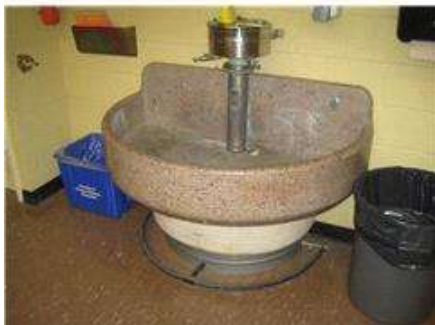
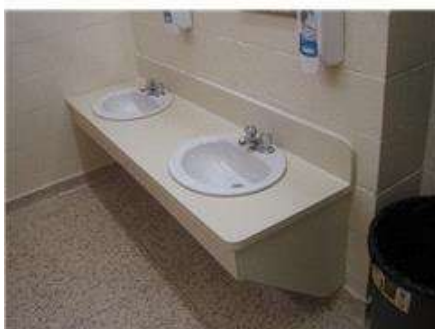
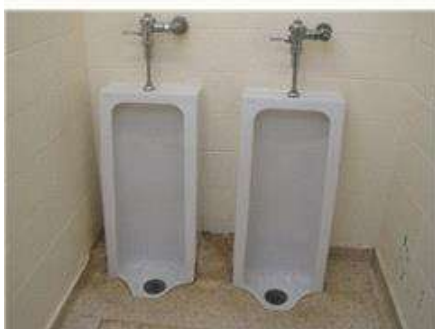
Condition Assessment 2013 – The majority of the plumbing fixtures are from 1966 and appear to be functioning but in poor condition. Some fixtures have been replaced over time. The majority of fixtures have surpassed the end of their normal service life. Planning for renewal is recommended.

2013 - The installation of plumbing fixtures appears to be original to the building construction. The fixtures are aged and in poor shape. Corrosion, staining and damage was noted on the fixtures. The replacement of outdated fixtures is recommended.

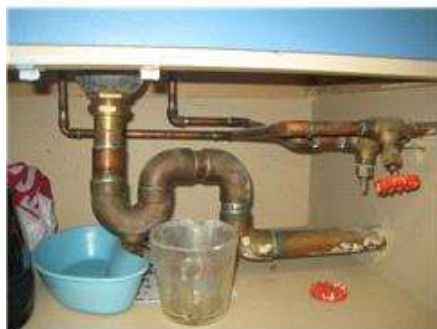
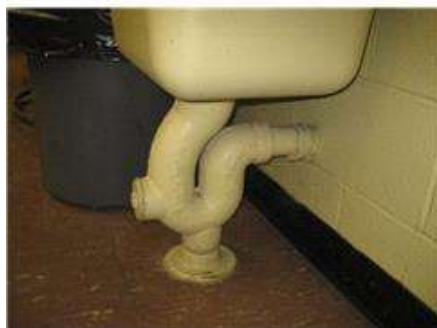
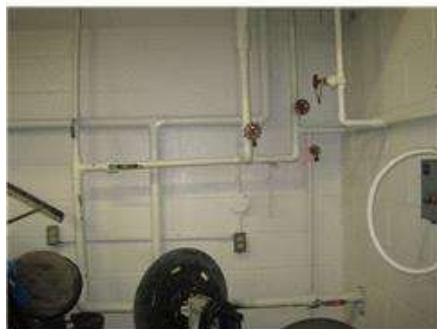
2013 - The plumbing piping system is mostly concealed and therefore the current condition is not fully known. Due to age and heavy use, piping has signs of corrosion and deterioration. However, an intrusive study is recommended to determine the condition of the plumbing piping system and the recommended scope of work and the cost for system renewal.

2013 - Plumbing piping has exceeded its theoretical service life; however, condition cannot be fully determined. Replacement is subject to results of proposed study to determine current condition. Cost and schedule of replacement to be determined by study. Deferral may result in poor functioning or leaking of plumbing pipes, likely causing damage to other building components.

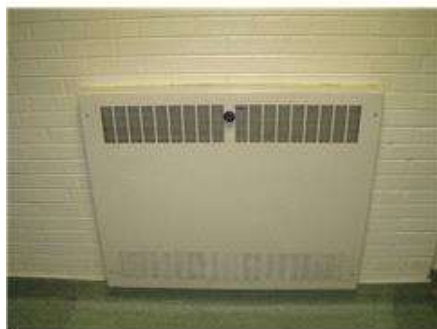
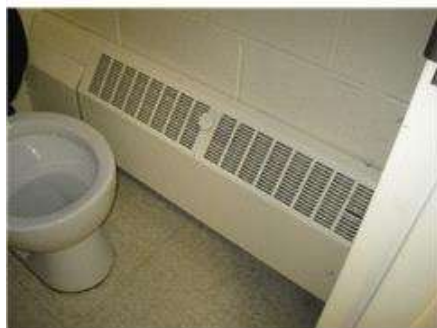
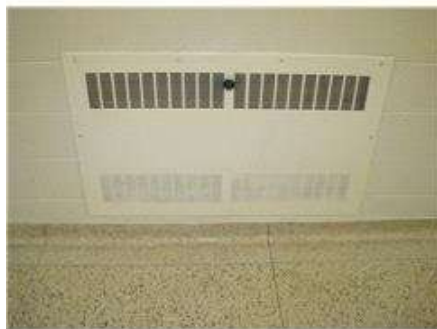
Condition Assessment 2013 - The fin-tube radiation units have exceeded their rated useful life of 15 years. Although portions have been properly maintained, the system has degraded in condition over the years. Due to age and deterioration the unit will require replacement soon.

Recommendation 2013 - Although terminal units have surpassed their typical service life they remain in poor condition at this time. Planning for renewal is recommended only during the latter portion of the tactical planning period.

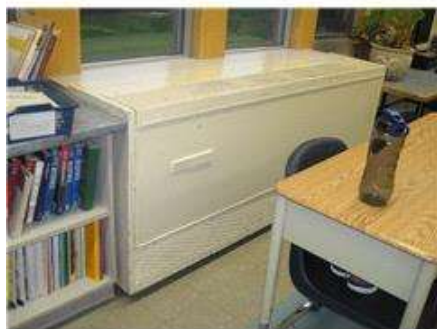
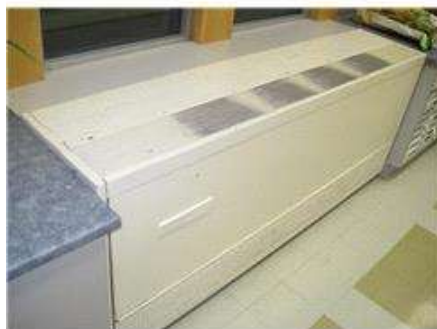
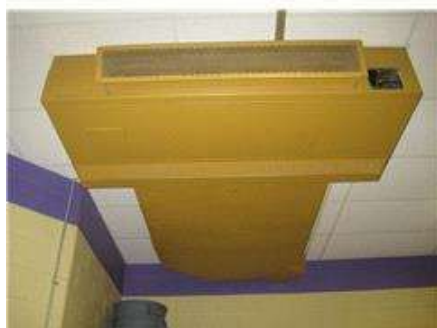
2013 - The unit ventilators have exceeded their rated useful life of 15 years. Although portions have been properly maintained, the system has degraded in condition over the years. Due to age and mechanical deterioration the unit ventilators have deteriorated, causing break down and problems thus affecting the Indoor Air Quality in the school and will require replacement soon.

2013 – Replace the aged unit ventilators. Consideration should be made to replace them with high efficiency units.

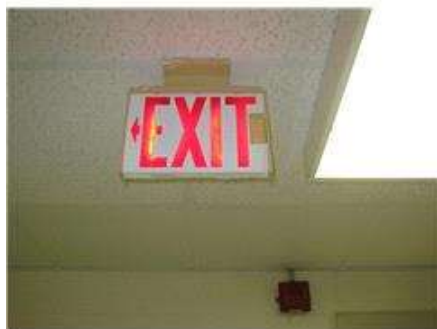
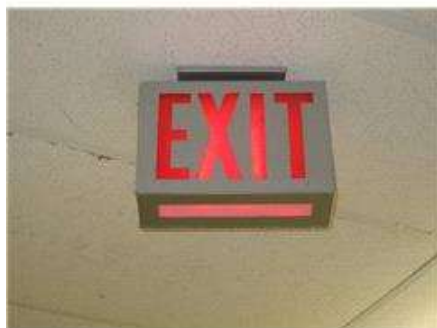
Description 2013 – Exit lighting in the school was originally installed in 1973.

Recommendation 2013 - Exit lighting system is functional at this time and is in fair condition. Replace existing aged lamps and fixtures with high efficiency lamps and batteries.

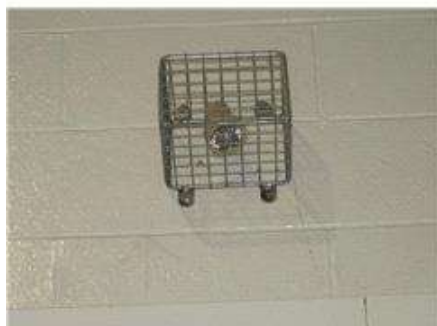
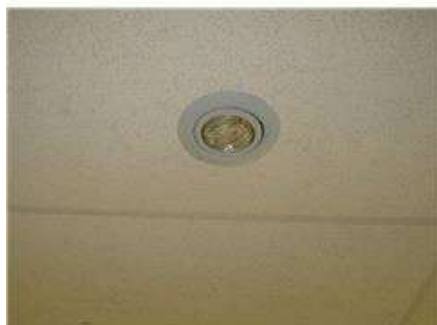
Description 2013 – Emergency Lighting in the school was originally installed in 1973.

2013 - Emergency lighting is functional at this time and is in fair condition. Replace existing aged lamps and fixtures with high efficiency lamps and batteries.
