Hastings and Prince Edward District School Board

Condition Assessment

Pinecrest Memorial Elementary School, Building ID 5953-1

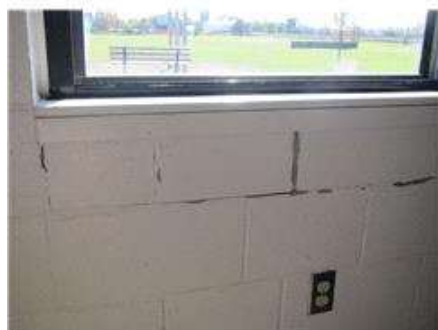
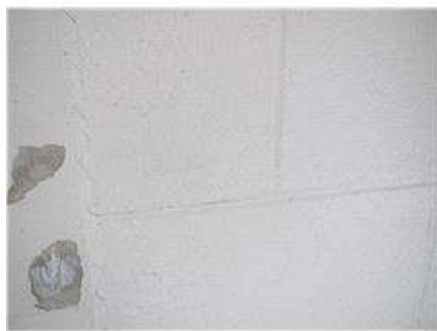
Condition Assessment 2013 – At the time of the assessment step cracks were observed in various areas of the facility along with corner wall cracks.

Recommendation 2013 - Repair as directed by the findings of the structural study The repair cost provided is for budgeting purposes only and should be confirmed in the recommended study.

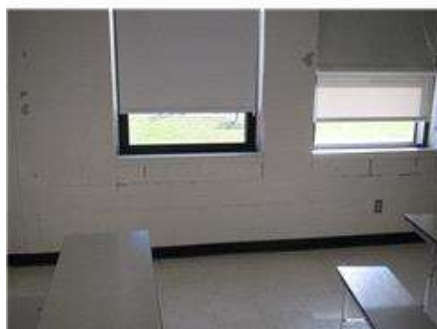
Description 2013 – Structural integrity – Step cracking (step cracks many times are an indication the footing under the foundation wall is moving.)

2013 - Step cracks many times are an indication the footing under the foundation wall is moving, based on this the recommendation is to retain a structural consultant to perform a structural study to determine repair and costs for such repairs as needed.

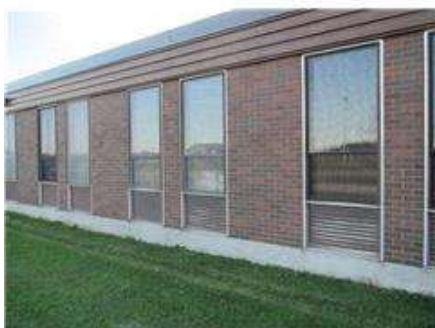
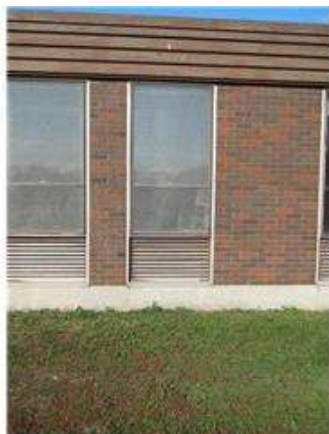
2013 - At the time of the assessment the building windows are currently performing adequately, but are considered to be in poor overall condition based on their age, outdated design and thermal properties. Additionally, some exterior seals were noted to be deteriorating, indicating probable future water and air leakage.

2013 - The windows of the building are beyond their expected service life. Based on the windows performance and observed condition, age, design and thermal properties, replacement of the building windows is recommended.

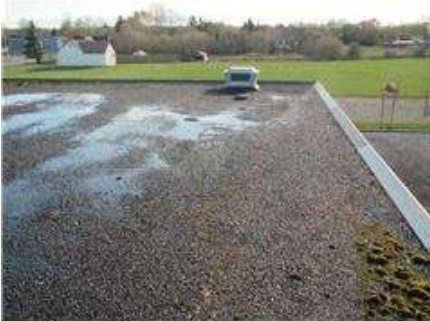
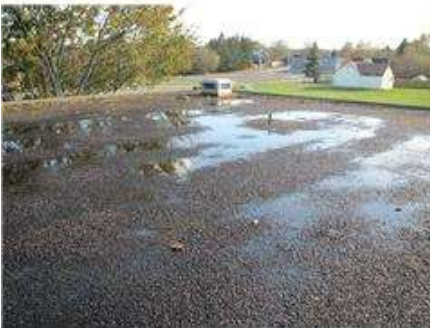
Condition Assessment 2013 - At the time of the assessment the condition of the aggregate-surfaced built up roof (BUR) assembly system on the original roof is consistent with its age, there are bare spots in the gravel and blistering is visible. The overall condition of the roof system is fair to poor

2013 - The aggregate-surfaced built up roof (BUR) assembly system on the original roof has exceeded its expected service life, but continues to perform as intended. Replacement is anticipated in 2017

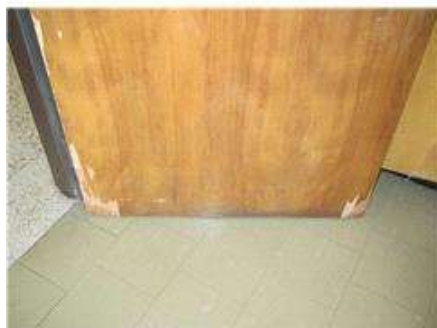
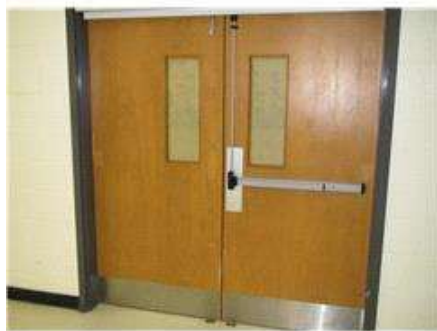
2013 - At the time of the assessment the majority of doors were observed to be aged and worn beyond useful life. Wood doors had damaged veneers, chipped paint, and some glazing was not tempered.

2013 - The interior doors date from 1967 and have exceeded their anticipated useful life. Early stages of deterioration were visible on the doors. Replacement is suggested.

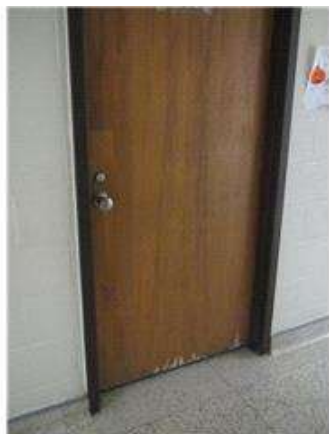
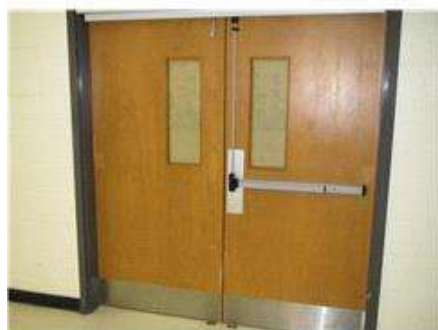
Condition Assessment 2013 - At the time of the assessment the interior door hardware was observed to be aged, worn and deteriorated. Corrosion was noted on various components.

Recommendation 2013 - The age of the interior door hardware is consistent with the age of the interior door. Replacement of the interior door hardware along with interior doors is recommended.

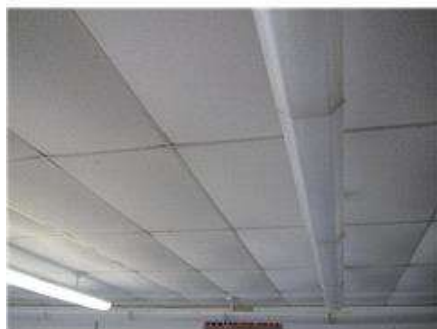
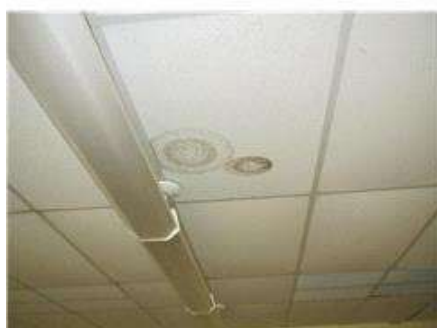
Condition Assessment 2013 - At the time of the assessment the 2'x4' acoustic ceiling tile is original to the building . There is some signs of staining, sagging and damage, and the ceiling system has exceeded its useful life expectancy.

2013 - The suspended ceiling tiles date to the building construction in 1967, and as such have surpassed their useful life. Sagging and deterioration as a result of age was evident on some tiles. Replacement of the tiles is anticipated.

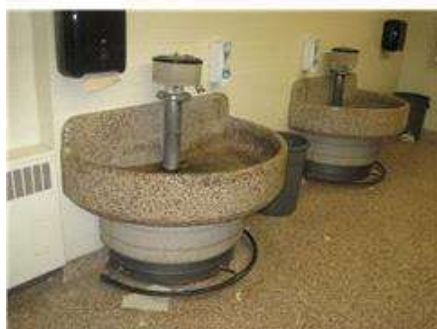
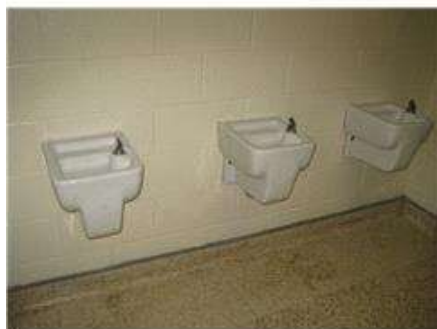
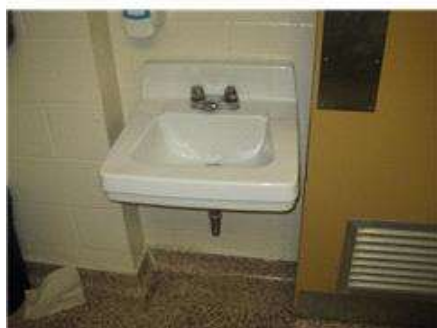
Condition Assessment 2013 – The majority of the plumbing fixtures are from 1967 and appear to be functioning but in poor condition. Some fixtures have been replaced over time. The majority of fixtures have surpassed the end of their normal service life. Planning for renewal is recommended.

Recommendation 2013 - The installation of plumbing fixtures appears to be original to the building construction. The fixtures are aged and in poor shape. Corrosion, staining and damage was noted on the fixtures. The replacement of outdated fixtures is recommended.

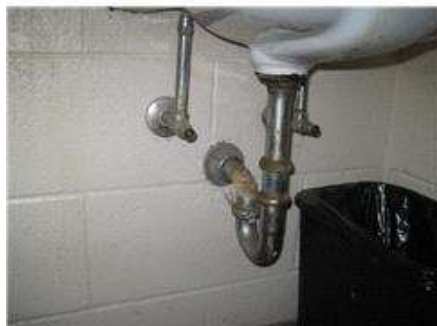
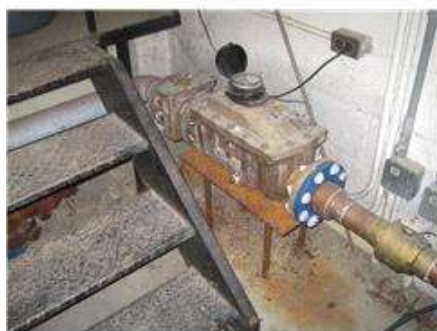
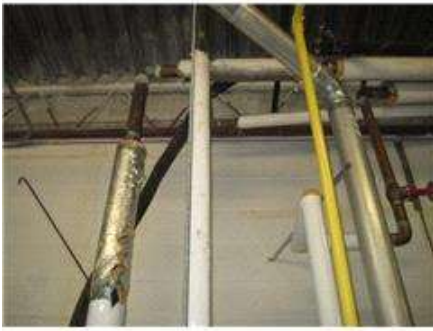
2013 - The plumbing piping system is mostly concealed and therefore the current condition is not fully known. Due to age and heavy use, piping has signs of corrosion and deterioration. However, an intrusive study is recommended to determine the condition of the plumbing piping system and the recommended scope of work and the cost for system renewal.

2013 - Plumbing piping has exceeded its theoretical service life; however, condition cannot be fully determined. Replacement is subject to results of proposed study to determine current condition. Cost and schedule of replacement to be determined by study. Deferral may result in poor functioning or leaking of plumbing pipes, likely causing damage to other building components.

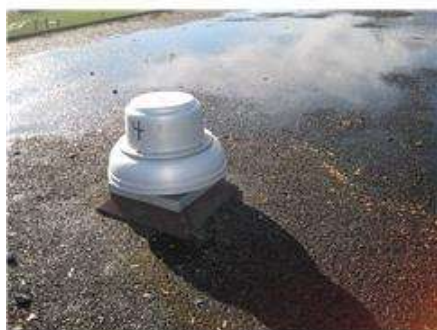
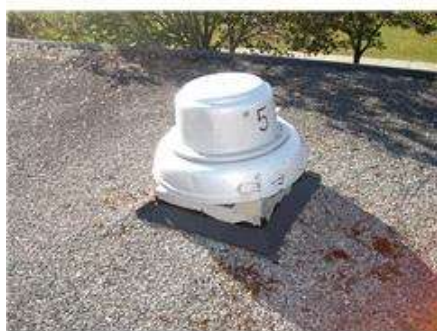
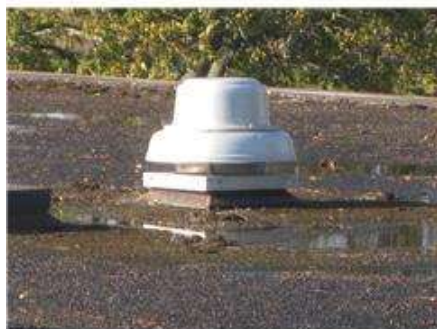
Condition Assessment 2013 - The exhaust fans are typically original to the building. Many fans have damaged casing and many were vibrating excessively. The fans are in poor condition overall.

2013 - The exhaust fans are operating but have passed their expected useful lives and will likely require replacement in the short term as many are in poor condition.

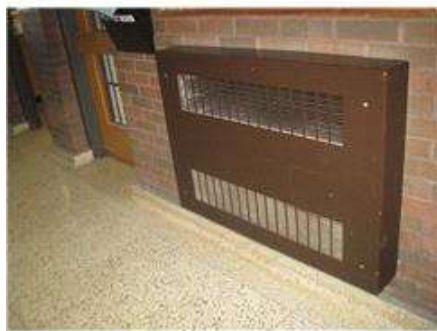
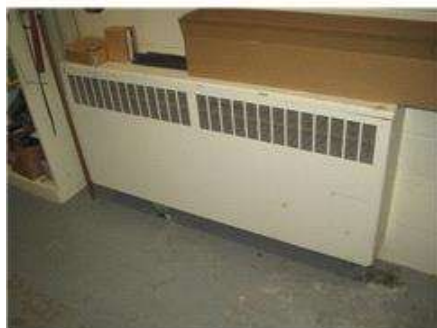
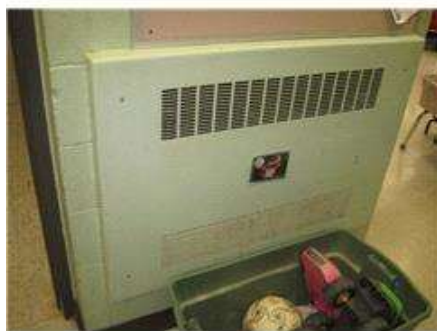
Condition Assessment 2013 - The fin-tube radiation units have exceeded their rated useful life of 15 years. Although portions have been properly maintained, the system has degraded in condition over the years. Due to age and deterioration the unit will require replacement soon.

Recommendation 2013 - Although terminal units have surpassed their typical service life they remain in fair condition at this time. Planning for renewal is recommended only during the latter portion of the tactical planning period.

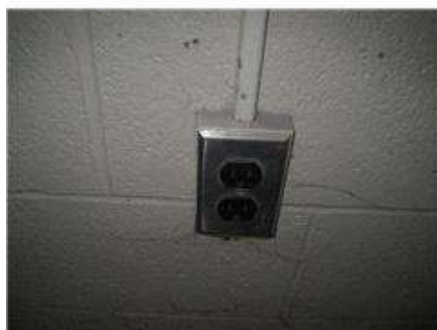
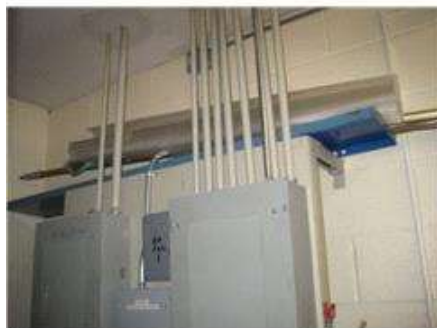
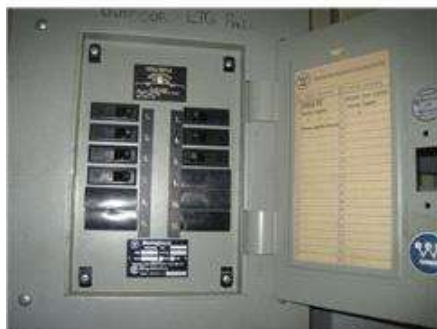
2013 – The switches, outlets, panels, and wiring throughout the building are outdated and inadequate. They have surpassed their theoretical life and exceeded the maximum capacity, replacement of these components is recommended. Replace cabling, raceways, bus ducts and breaker panels based on age, useful life and existing capacity. Cost provided is an estimate; a more accurate cost will depend on the evaluation study.

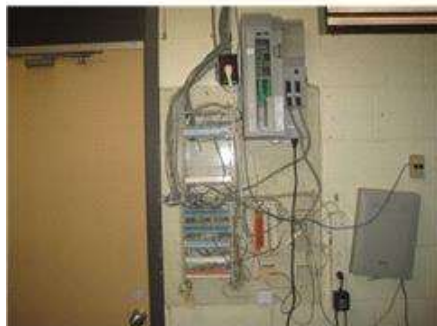
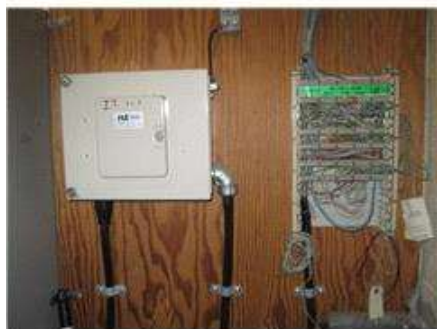
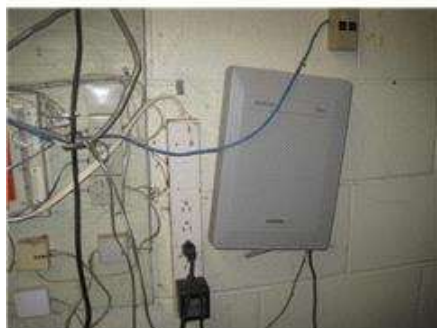
2013 - Phone system is over 20 years old. The system is in fair condition but functional at this time. The phone system is aged and beyond its rated life and is recommended for replacement.
