Mechanical & Electrical Condition Assessment

Prince Edward Collegiate Institute, Building ID 8347-1

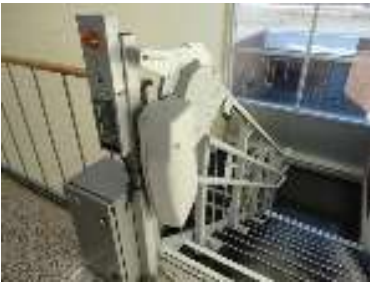
2012 - No major deficiencies were reported or observed. The chair lifts and the passenger elevator are generally performing as intended. Based on age, they are considered to be in fair condition.

Aug 2012 - Aged chair lifts

2012 - Based on the age, the passenger elevator and the chair lifts have surpassed their expected useful life, which is approximately 30 years. Replacement of the passenger elevator and the chair lifts in 2014 is recommended to minimize maintenance costs and potential safety hazards.

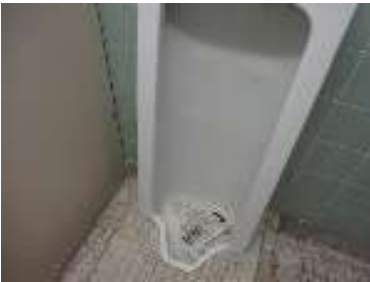
2012 - Two washrooms have recently renovated and are in good conditions. The remaining 90% of plumbing fixtures in the building are in poor condition, replacement is recommended.

Aug 2012 - Aged urinal

2012 - 90 percentage of the plumbing fixtures have exceeded their expected useful life, which is approximately 25 years. Replacement of the deteriorated plumbing fixtures is recommended to ensure continued operation.

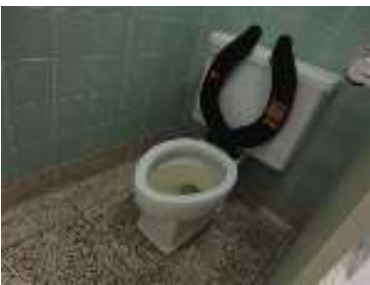
Aug 2012 - Aged water closet

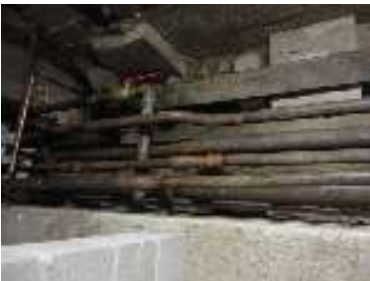
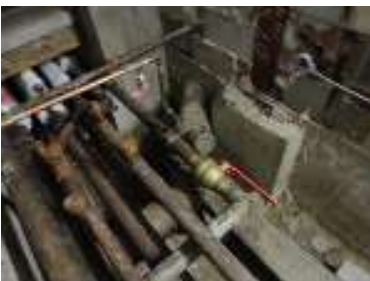
2012 - No significant problems were reported with the building's plumbing piping system. Approximately 80 percent of the plumbing

pipng system is original to the construction of the original building and Addition 1, 2 & 3 in 1953, 1960, 1962 and 1967 respectively. A study to evaluate the condition of the plumbing piping system and to provide a cost for replacement is recommended.

Aug 2012 - Aged plumbing piping system

2012 - The plumbing piping system is mostly concealed and therefore its current condition is not fully known. With age, a plumbing piping system is known to develop pinhole leaks. Given its current age, an intrusive study is recommended to determine its condition.

2012 - Repair or replacement of the plumbing piping system may be required according to the results of the proposed study. The cost provided is for budgeting purposes only. The replacement scope of work is subject to the recommendation of the study. Deferral of the replacement may result in further deterioration of the water supply.

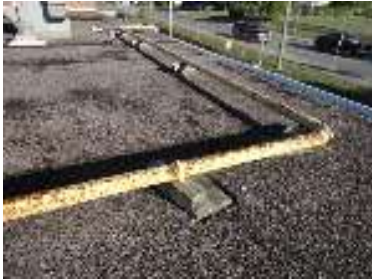
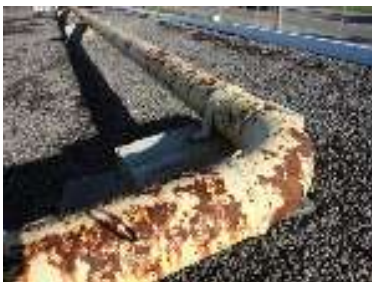
2012 - Corrosion was reported and observed on the main rooftop line and the line serving the science lab. The gas piping system is in poor condition based upon age and observed condition.

Aug 2012 - Aged gas piping system

2012 - Repair or replacement of the gas piping system may be required to ensure a continuous and reliable supply of fuel to the building.

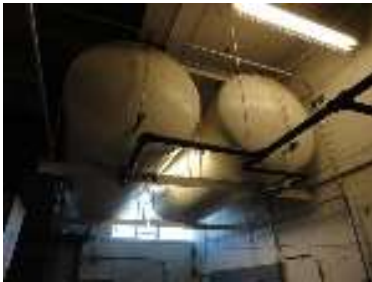
2012 - The expansion tanks are aged and are in fair condition.

Aug 2012 - Aged expansion tanks

2012 - The expected useful life of the expansion tanks is approximately 20 years. Based on age, replacement of the expansion tanks is recommended to ensure continued operation of the boiler heating loop.

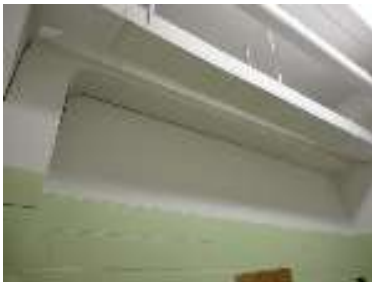
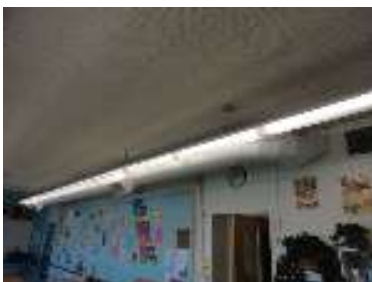
2012 - 40 percent of the duct system was replaced in 2009 and is in good condition. The remainder of the duct system is suspected to be in fair condition based on age. A study is recommended to confirm condition and to recommend remedial action.

Aug 2012 - Aged duct system

2012 - In order to determine the condition and remaining expected useful life of 60 percent of the duct system, a study is recommended.

2012 - Pending the outcome of the recommended study, a replacement of the duct system may be required. The cost provided is for budgeting purpose only. The replacement schedule, scope and cost of the system are subject to the proposed study.

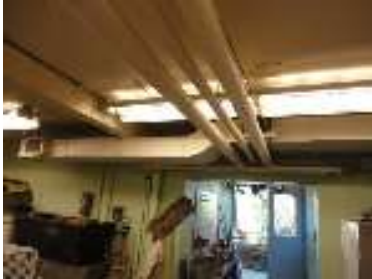
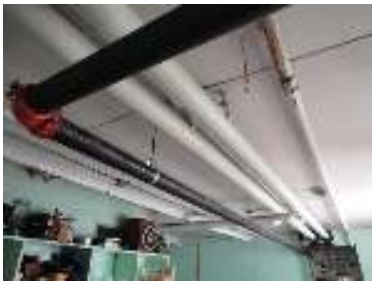
2012 - The condition of the piping system could not be determined during the site assessment because it was not easily accessible. Approximately 90 percent of the heating piping system is likely original to the building construction and is suspected to be in poor condition.

Aug 2012 - Aged heating piping system

2012 - The heating piping system is known to develop pinhole leaks with age. In order to check the condition of the concealed heating piping system, an intrusive investigation is recommended.

2012 - Based on the age and condition of the heating piping system, replacement is recommended. The cost provided is for budgeting purposes only. The replacement schedule, scope and cost of the system are subject to the proposed study. The budget cost, which was

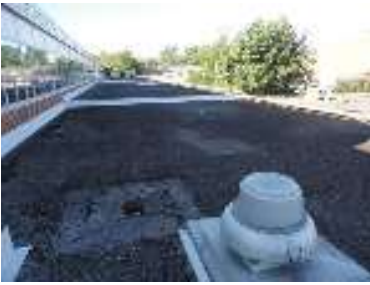
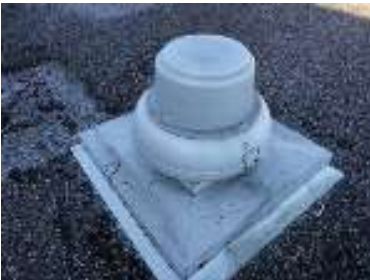
2012 - 17 roof-top and four room exhaust fans are aged and in poor condition. The remaining fans are in good condition.

Aug 2012 - Aged exhaust fans

2012 -17 roof-top and four room exhaust fans have surpassed their expected useful life. Replacement of the aged exhaust fans is recommended to maintain indoor air quality.

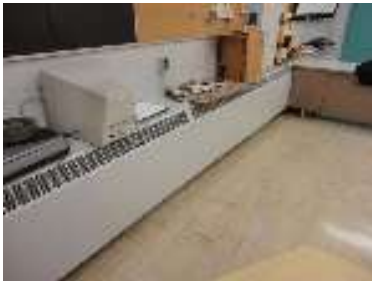
2012 - 40 percentage of the perimeter radiators were replaced in 2009 and remain in good condition. The remaining 60 percent of the perimeter radiators are aged and in fair condition. Fan coils located at the stairs and entrances are also aged and considered to be in fair condition. There are 10 unit heaters which are considered to be in poor condition based on age.

Aug 2012 - Aged perimeter radiator

2012 - With age, unit malfunction or breakdown is anticipated which increases maintenance costs. Replacement of the aged terminal units is recommended.

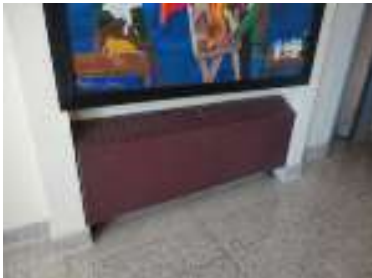
Aug 2012 - Aged unit heater

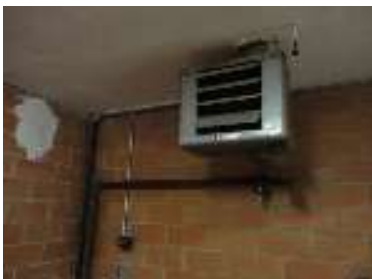
Aug 2012 - Aged space heater

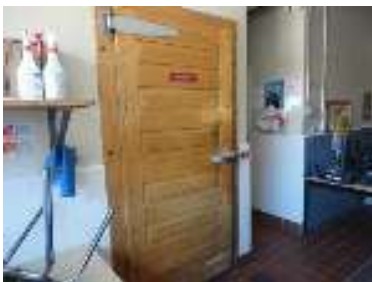
2012 - The freezer appears aged and has surpassed its expected useful life. Based on age and reported operating condition, the unit is in poor condition.

Aug 2012 - Aged walk-in freezer

2012 - Replacement of the walk-in freezer is recommended to ensure continued operation. Failure to replace the unit may affect the function of the kitchen.

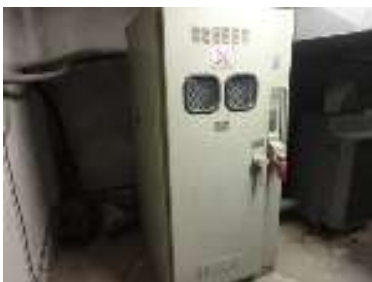
2012 - Based on age, the transformers are in poor condition.

Aug 2012 - Aged three phase main transformer

2012 - The transformers have exceeded their expected useful life. Failure of the transformers can significantly disrupt operation of the building. Replacement of the transformers is recommended.

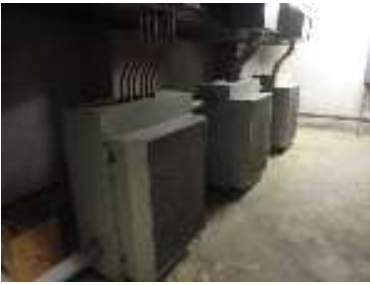
Aug 2012 - Aged one phase main transformers

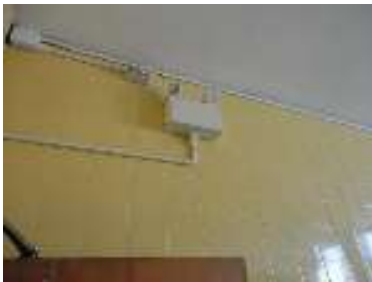
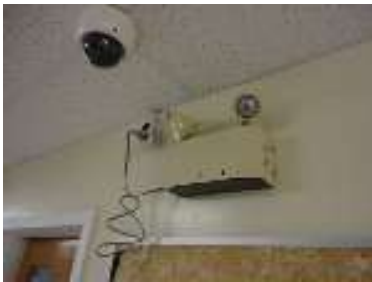
2012 – Based on age and observation, the emergency lighting is in poor condition. The emergency lighting has inadequate coverage in the building.

Aug 2012 - Aged emergency lighting

2012 – The emergency lighting has exceeded its expected useful life. Over time, deterioration of the battery packs and light fixtures may impact the safety of occupants during emergency evacuation. Replacement of the emergency lighting is recommended.

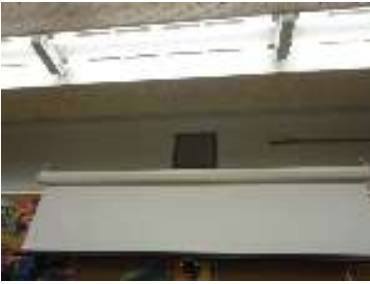
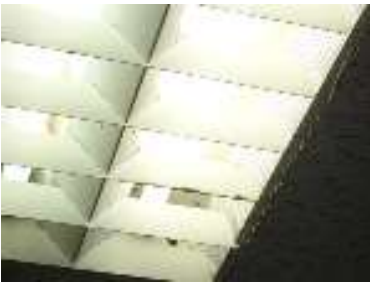
2012 – Based on age and observation, 20% of the interior lighting is in fair condition. Some fixtures appear to be damaged.

Aug 2012 - Aged interior lighting

2012 – 20 percent of the interior lighting has exceeded its expected useful life. Over time, deterioration of the light fixtures may impact

the learning environment. Replacement of the interior lighting is recommended.

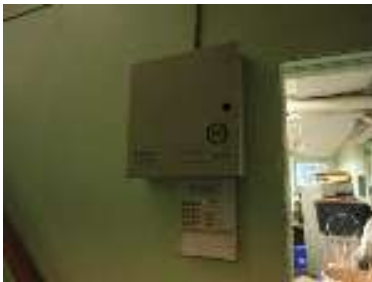
2012 – Based on age and observation, the fire alarm system is in poor condition. The control panel is reportedly obsolete.

Aug 2012 - Aged fire alarm system

2012 – The fire alarm system has exceeded its expected useful life. Failure of the fire alarm system may impact the safety of occupants. Replacement of the system is recommended.

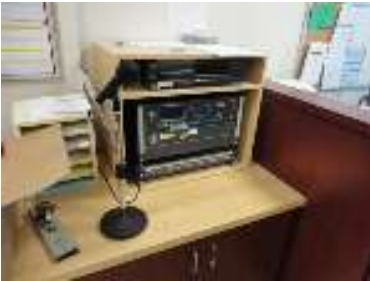
2012 – Based on age and observation, the Public Address (PA) system is in poor condition. The control unit is obsolete. The speaker system is old and damaged, some speakers are not working at all.

Aug 2012 - Aged public address system control unit

2012 – The PA system has exceeded its expected useful life. Replacement of the system is recommended.

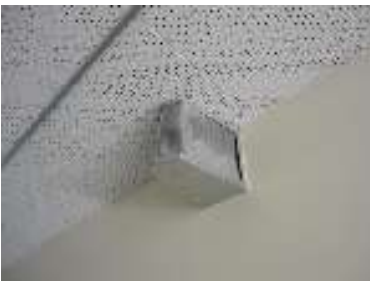
Aug 2012 - Damaged speakers

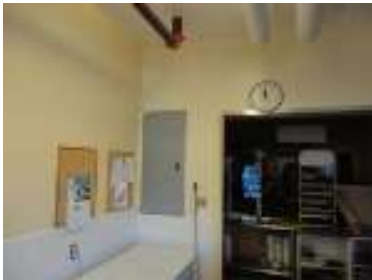
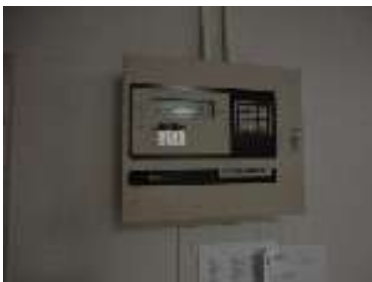
2012 - Based on age, the clock system is in fair condition. No major deficiencies were reported at the time of the assessment.

Aug 2012 - Aged clock system

Aug 2012 - Aged simplex clock program

2012 - The central clock system is at the end of its expected useful life, which is approximately 25 years. Replacement is recommended.

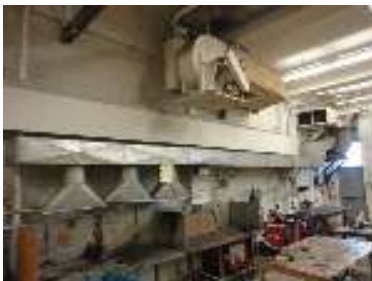
2012 – The dust collector is aged and considered to be in poor condition.

Aug 2012 - Aged dust collector duct

2012 – Replacement of the aged dust collector is recommended to eliminate the repeated high maintenance costs.

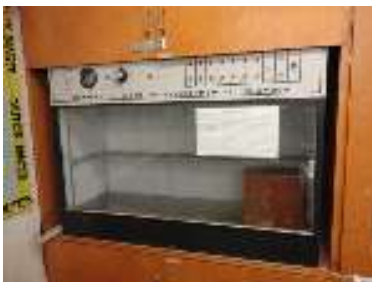
2012 – Based on age, the environmental chamber is in poor condition. No major deficiencies were observed or reported at the time of the assessment.

Aug 2012 - Aged environmental chamber

2012 – Based on age and observed conditions, replacement of the environmental chamber is recommended in order to ensure continuous operation of the equipment and minimize disruption.
