Hastings and Prince Edward District School Board

Condition Assessment

Queen Elizabeth School (Picton), Building ID 6529-1

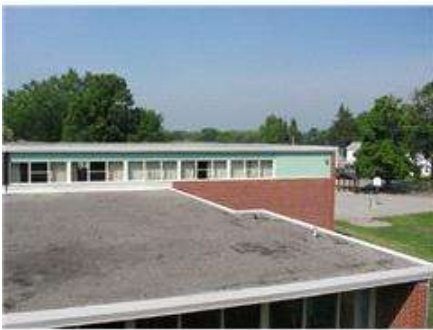
2012 - The condition of the roofing is consistent with its age and is in fair overall condition, with areas of blueberry blisters and ridges noted at the time of the assessment. No active roof leaks were reported at the time of the assessment.

OLD_View of bleed through on the roof.

2012 - The roofing has exceeded its expected useful life. Based on age and observed condition, replacement is recommended.

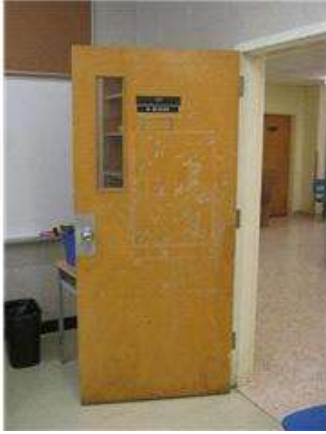
August 2012 - Worn and scratched interior wood door noted

Recommendation 2012 - The interior doors of the building have exceeded their expected useful life. Based on age and observed condition, replacement is recommended.

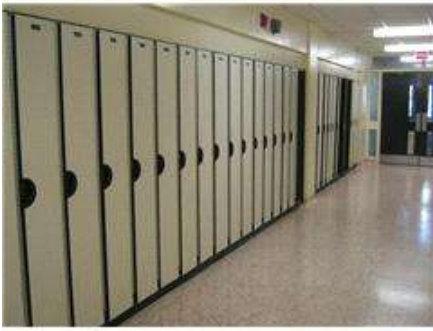
August 2012 - Corroded base of locker noted

Recommendation 2012 - The student storage lockers have exceeded their expected useful life. Based on age and observed condition, replacement is recommended.

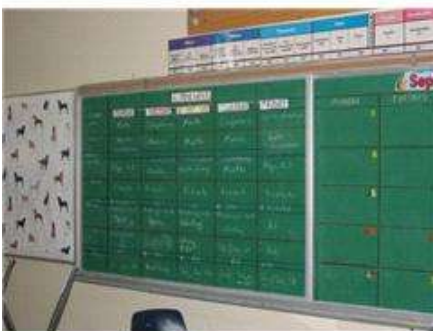
OLD_View of worn chalk tray.

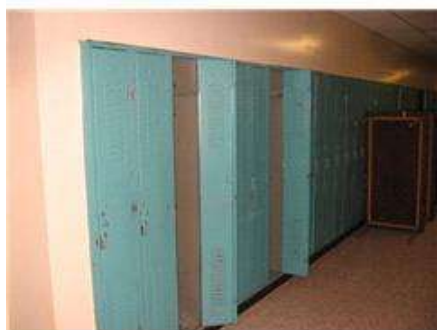
OLD_View of corrosion on the lockers.

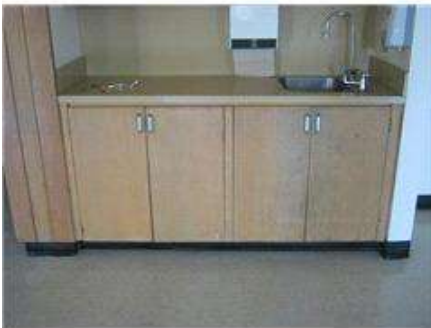
August 2012 - Damaged millwork noted

2012 - The millwork in the building has exceeded its expected useful life. Based on age and observed condition, replacement is recommended.

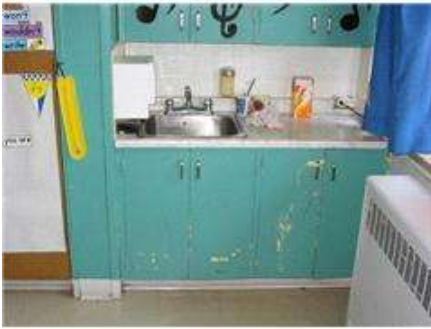
OLD_View of millwork finish and hardware.

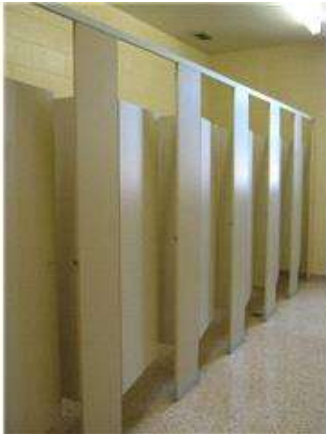
August 2012 - Delaminated washroom partition noted

2012 - The washroom partitions are approaching their expected useful life. Based on age and observed condition, replacement is recommended.

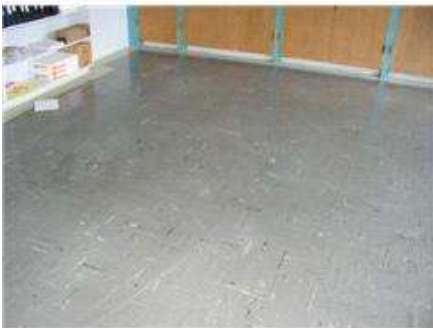
OLD_View of the worn vinyl floor tile.

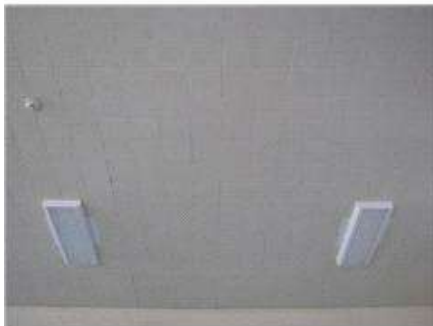
August 2012 - Debonded acoustic ceiling tiles noted

2012 - The fixed acoustic tile ceilings are beyond their expected useful life. Based on age and observed condition, replacement is recommended.

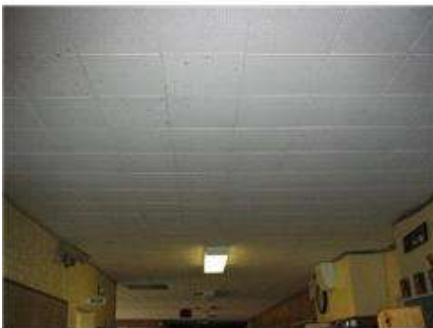
OLD_View of loose and damaged ceiling tiles.

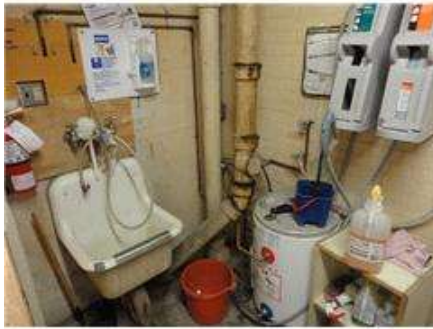
August 2012 - Aged plumbing piping

2012 - The plumbing piping system is mostly concealed and therefore its current condition is not fully known. With age, a plumbing piping system is known to develop pinhole leaks. Given its current age, an intrusive study is recommended to determine its condition.

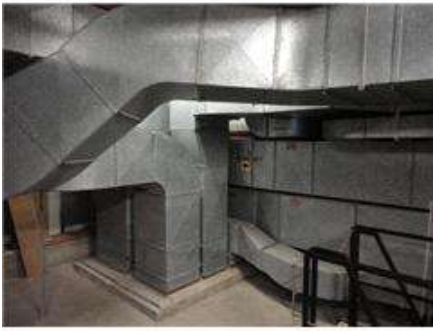
August 2012 - Aged duct system

Recommendation 2012 - In order to determine the condition and remaining expected useful life of the duct system, a study is recommended.

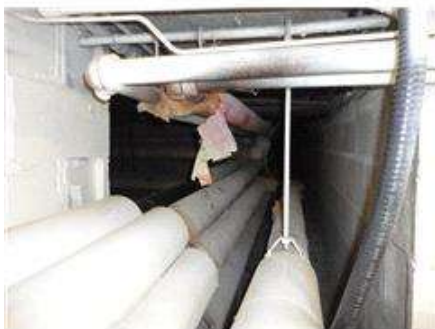
August 2012 - Aged heating piping

Recommendation 2012 - The heating piping system is known to develop pinhole leaks with age. In order to check the condition of the concealed heating piping system, an intrusive investigation is recommended.

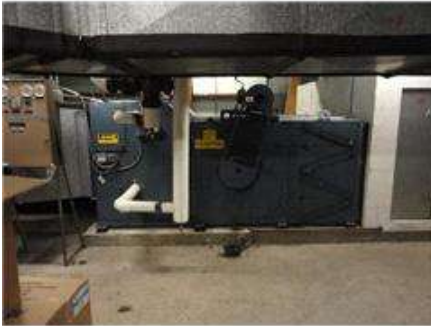
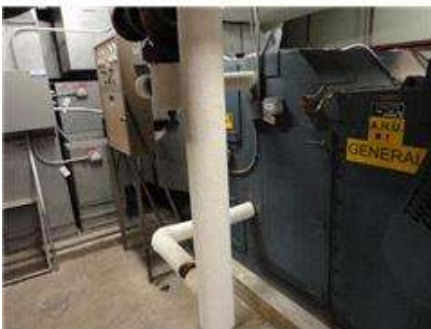
August 2012 - Central station air handling unit (AHU)

August 2012 - Closed view of central station AHU

2012 - Based on the age, the central station air handling units (AHUs) have exceeded the expected useful life, which is approximately 35 years. With age, the likelihood of the components failing increases, which may result in a system malfunction that will impact the indoor environment. Replacement of the aged central station AHUs is recommended.

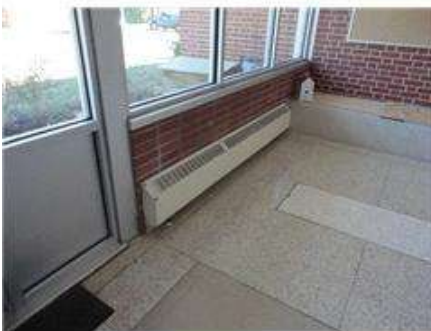
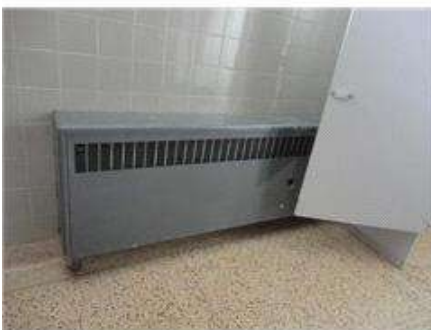
August 2012 - Perimeter radiators

August 2012 - Aged terminal unit

2012 - With age, unit malfunction or breakdown is anticipated which increases maintenance costs. Replacement of the aged terminal units is recommended.

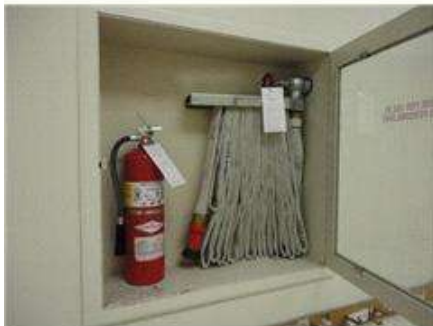
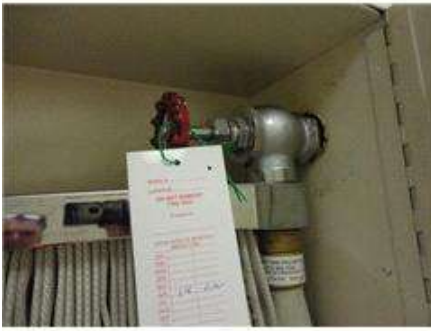
August 2012 - Standpipe system

August 2012 - Closed view of standpipe system

2012 - Based on the age, the standpipe system has exceeded its expected useful life, which is approximately 47 years. A study to determine the condition and remaining useful life is recommended.

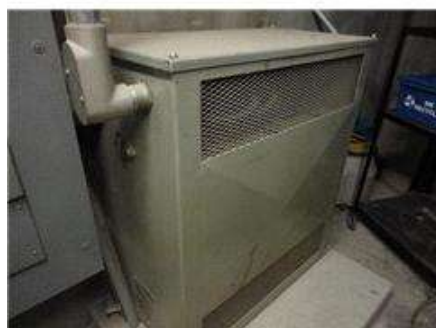
August 2012 - Secondary transformer

2012 - The transformer has exceeded expected useful life. Failure of the transformer can affect operation of the building. Replacement of the transformer is recommended.

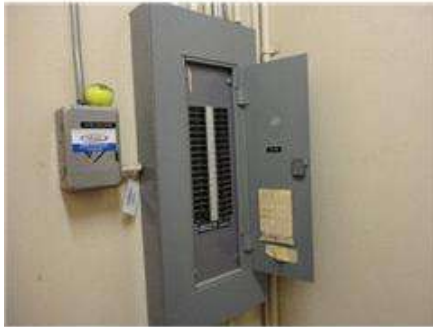
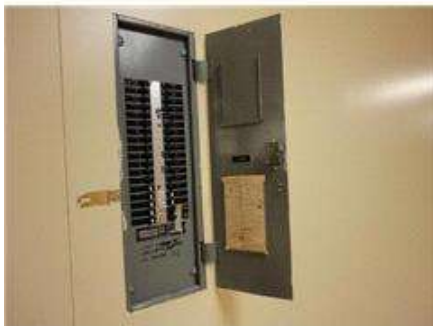
August 2012 - Distribution panel

August 2012 - Aged distribution panel

2012 - The secondary switchgear which is original to the building construction in 1953 and its addition in 1968 has exceeded expected useful life. Over time, carbon build-up and electrical arcing can occur. Replacement of the switchgear is recommended.

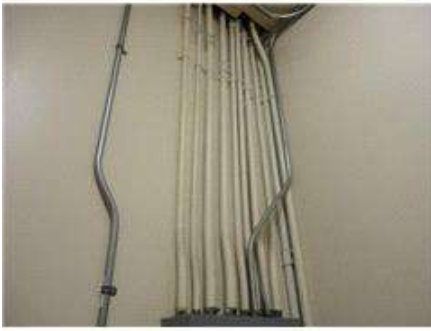
August 2012 - Aged branch wiring

Recommendation 2012 – The electrical wiring has exceeded its expected useful life. Over time, deterioration of the wire insulation and the conduit can occur. Some wiring may have been added or replaced but the extent of the modifications is not clear. Given the age of the electrical wiring, a study is recommended to determine the integrity of the wiring and to provide a scope and schedule of replacement.

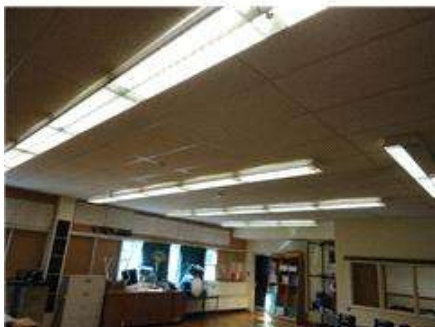
Condition Assessment 2012 – Based on age, the interior lighting at the lower levels is in fair condition. The lighting appears to perform as intended.

August 2012 - Interior lighting

Recommendation 2012 – The interior lighting at the lower level installed in 1968 has exceeded expected useful life. Over time, deterioration of the light fixtures may impact the learning environment. Replacement of the interior lighting is recommended.

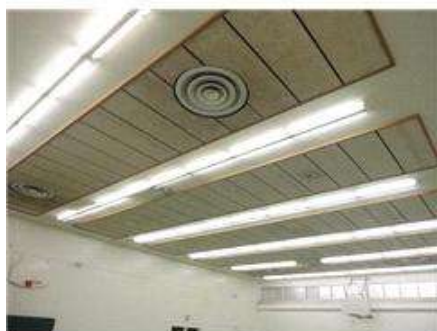
August 2012 - Interior lighting

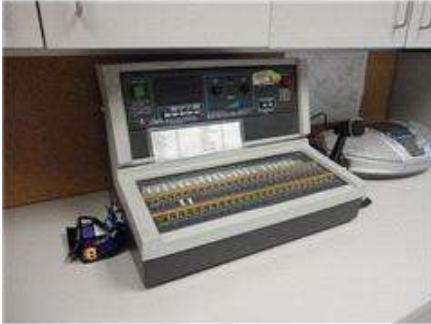
Condition Assessment 2012 – Based on age, the Public Address (PA) system is in poor condition.

August 2012 - Public address system

2012 – The public address (PA) system has exceeded its expected useful life. Replacement of the system is recommended.

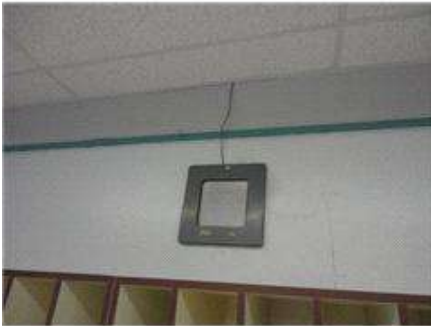
August 2012 - Aged speaker

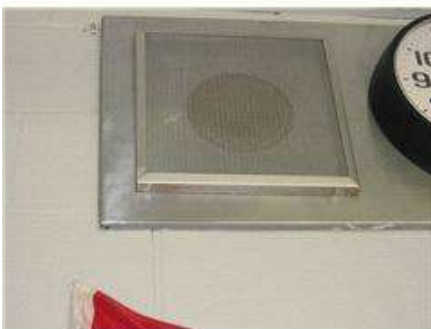
OLD_Classroom communication system is outdated

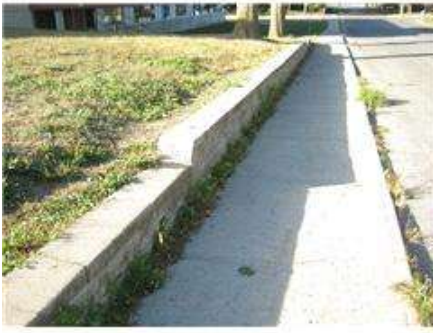
Condition Assessment 2012 - The concrete paved walkways are in poor overall condition, with transverse and alligator cracking as well as ravelling observed.

August 2012 - General view of concrete paved walkway

Recommendation 2012 - The concrete paved walkways are beyond their expected useful life. Based on age and observed condition, replacement is recommended.

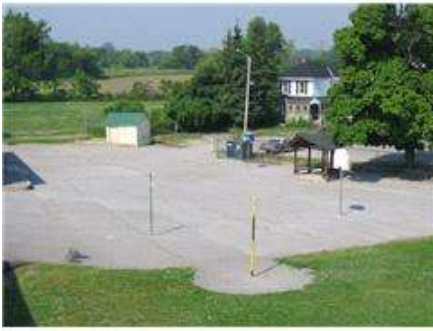
Condition Assessment 2012 - The asphalt paved schoolyard is in poor overall condition. At the time of the assessment, transverse, longitudinal, meandering and alligator cracking was noted, heaving and raveled pavement. All of which indicates that the pavement and its sub-structure is beginning to fail.

OLD_View of paved playground.

2012 - The asphalt paved schoolyard is beyond its expected useful life. Based on age and observed condition, replacement of the asphalt is recommended.
