Hastings and Prince Edward District School Board

Condition Assessment

Kente Public School, Building ID 6095-1

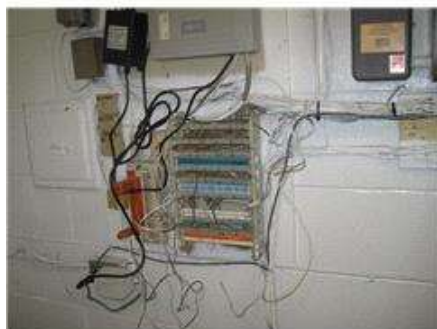
10/31/2013 8:21:51 PM Replacement [D503099 Other Communications & Alarm Systems - Original Building & Addition 1]

Recommendation 2013 - Communication system is over 20 years old. Communication system is obsolete but functional at this time and is in fair condition. The phone System is aged and beyond its rated life and is recommended for replacement.
