Hastings and Prince Edward District School Board

Condition Assessment

Pinecrest Memorial Elementary School, Building ID 5953-1

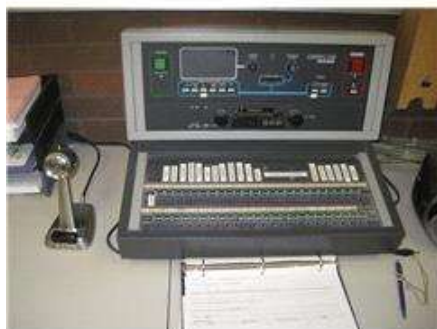
11/21/2013 5:35:16 PM Replacement [D503004 Public Address Systems - Original Building]

Recommendation 2013 - Communication system is over 40 years old. The PA system is in fair but functional at this time and is in fair condition. The Public Address System is aged and beyond its rated life and is recommended for replacement.
