### Architectural & Site Condition Assessment

Prince Edward Collegiate Institute, Building ID 8347-1

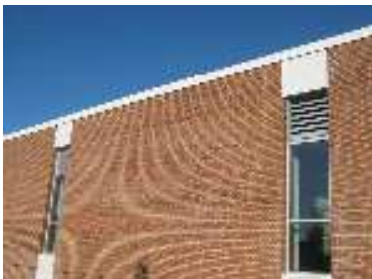
2012 - The exterior wall system is generally in poor condition. Areas of efflorescence were observed on the face of the brick and areas of cracking were observed in the face of the brick and within mortar joints which are located on the north elevation of the building in both stairwell block of the addition 2. The brick wall system is in poor overall condition. At the time of the assessment, areas of brick deterioration were noted in the form of spalled and cracked bricks. The mortar joints are also in poor condition, with areas of deteriorated mortar noted, typically in the same areas as the deteriorated brick.

August 2012 - General view of brick wall system

2012 – Areas of efflorescence on the face of the brick veneer were observed. Failure to undertake the recommended remedial work may result in further moisture intrusion within the building envelope and accelerated deterioration of the exterior wall system. Areas of vertical and step cracking were observed in the brick veneer. It is recommended that the deteriorated sections of brick be repaired, the repairs may involve crack sealing, localized replacement of brick units, and repointing of mortar. In order to maintain the intended performance of the wall system, it is recommended that the brick wall be repaired, which will require mortar repointing and occasional brick replacement.

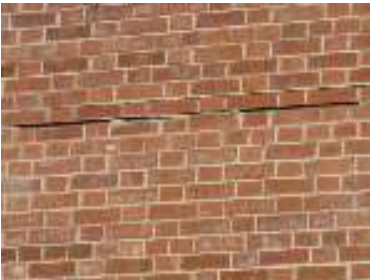
August 2012 - Mortar joint deterioration

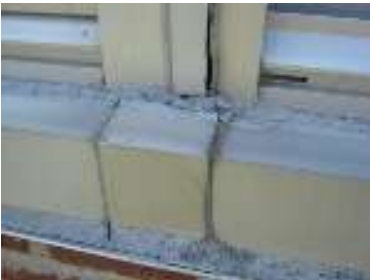
2012 - The sealant is in fair condition. The sealant observed has lost elasticity and exhibits adhesive and cohesive failure.

August 2012 - Cohesively failed window observed

2012 – The sealant has exceeded its expected useful life. In order to maintain the performance of the building's exterior envelope, replacement of the sealant is recommended.

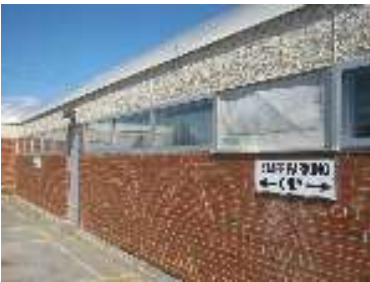
2012 - The stucco coating on the exterior walls is in fair condition. At the time of the assessment, cracked, spalled and deteriorated areas of stucco coat were observed.

August 2012 - General view of stucco finish on exterior walls

2012 – The stucco coating has exceeded its expected useful life. Based on age and observed condition, replacement is recommended.

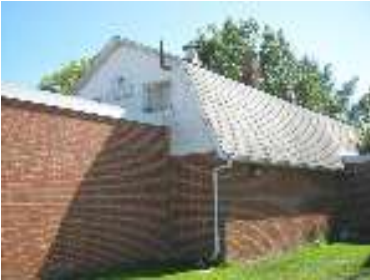
2012 – The windows of green house are in poor overall condition, with an aged appearance, wood rot and deteriorating frames.

August 2012 - General view of wood framed window in green house

2012 - The windows of green house have exceeded their expected useful life. Based on the age and observed condition, replacement of these windows is recommended.

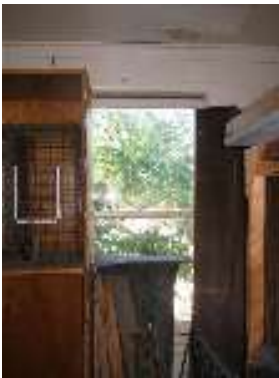
August 2012 - Aged appearance of wood framed window

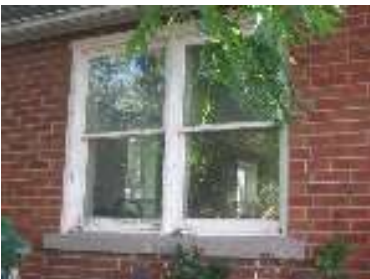
August 2012 - Wood rot and deterioration observed

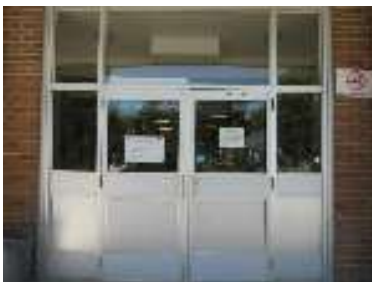
2012 - Approximately one aluminum main door and nine hollow metal exterior doors and frames of the building appear to be in fair overall condition, with faded paint, corrosion, damage, wear and a generally aged appearance.

August 2012 - General view of aluminum exterior door

2012 - Approximately one aluminum main door and nine hollow metal exterior doors and frames of the building are beyond their expected useful life. Based on age and observed condition, replacement of the exterior doors and frames is recommended.

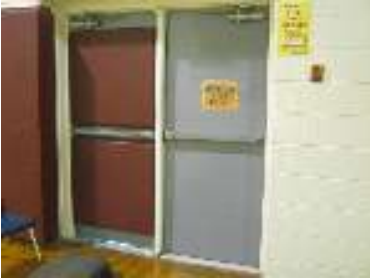
August 2012 - Deteriorated exterior metal door observed

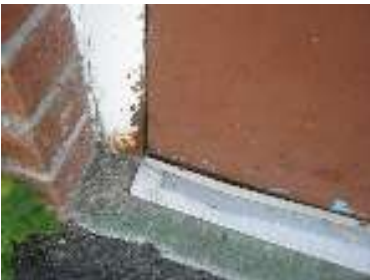
August 2012 - Corrosion at the base of door frame

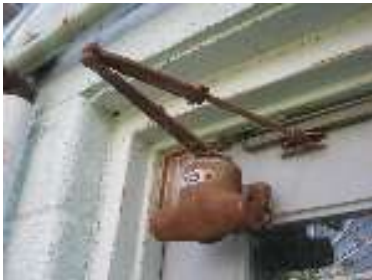
August 2012 - Corroded and aged door closer observed

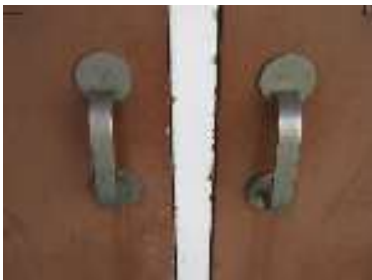
August 2012 - Aged and worn door handles observed

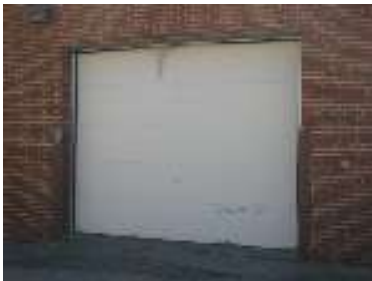
August 2012 - General view of wood overhead door

2012 - The wood overhead doors of the building have exceeded their expected useful life. The doors exhibit physical damage and are not functioning as intended. Based on age and observed condition, replacement is recommended.

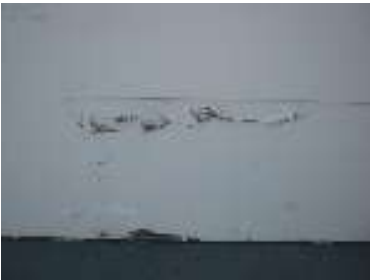
August 2012 - Peeling paint observed

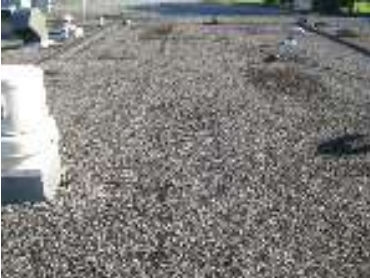
August 2012 - Ridges on built-up roof observed

2012 - The roofing for Roof Sections 14, 15, 17 & 18 has exceeded its expected useful life. Based on age and observed condition, replacement is recommended.

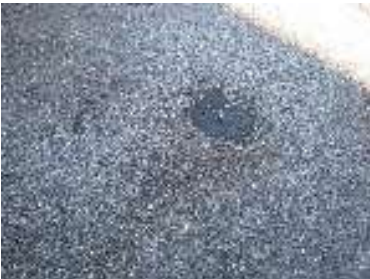
August 2012 - Exposed membrane observed

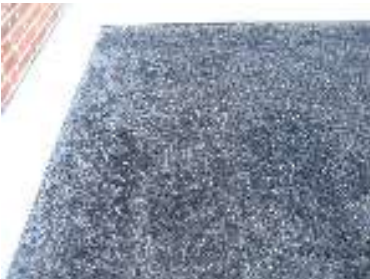
August 2012 - Blisters observed

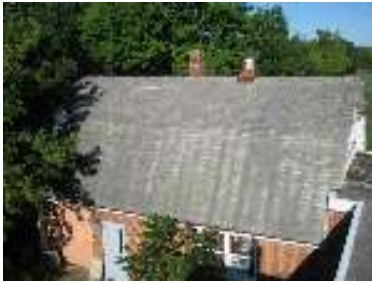
August 2012 - General view of asbestos shingles in horticulture building

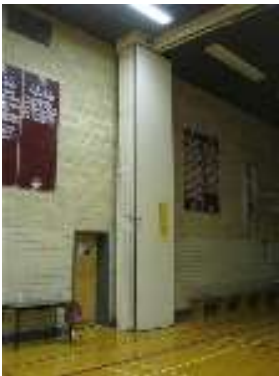
August 2012 - General view of moveable partition in gymnasium B

2012 - The moveable partition is approaching its expected useful life. Based on age and observed condition, replacement is recommended.

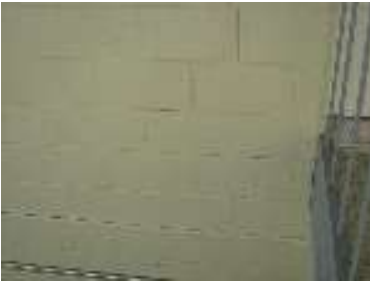
August 2012 - Step cracks in concrete masonry walls

2012 - Repair of the interior concrete masonry partition walls is recommended in order to improve interior aesthetics.

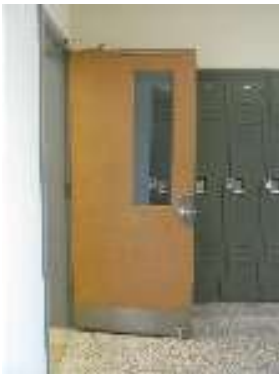
August 2012 - Typical wood interior door

2012 - The interior doors of the building are approaching their expected useful life, are damaged. Based on age and observed condition, replacement is recommended.

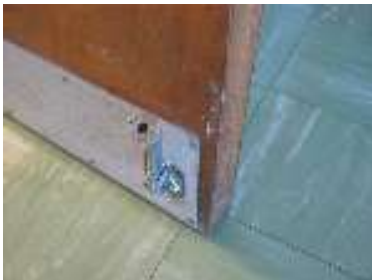
August 2012 - Damage and deterioration observed

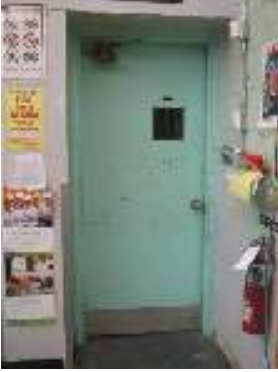
August 2012 - Aged and worn appearance interior metal door

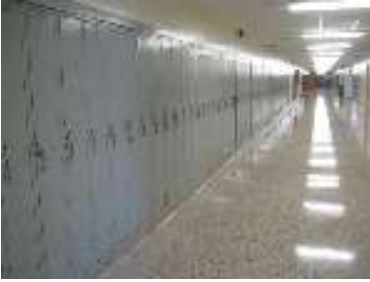
August 2012 - General view of metal lockers

2012 - The student storage lockers are approaching their expected useful life. Based on age and observed condition, replacement is recommended.

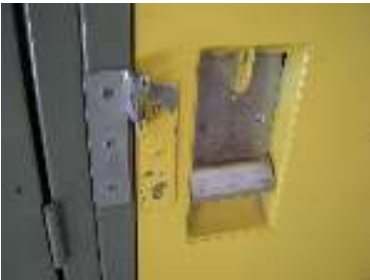
August 2012 - Damaged and corroded hardware observed

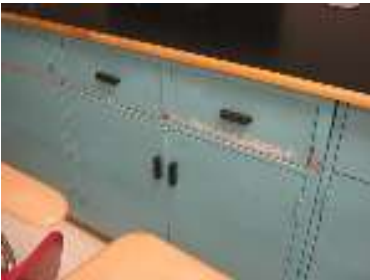
August 2012 - Worn and deteriorated millwork observed

2012 - Approximately 30% of millwork in the building are approaching its expected useful life. Based on age and observed condition, replacement is recommended.

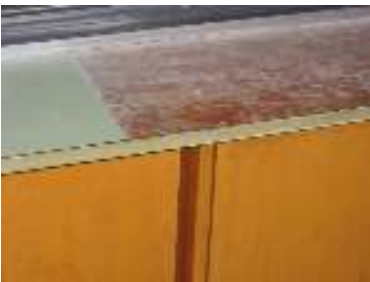
OLD\_View of missing laminate countertop.

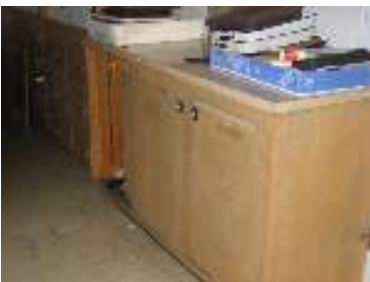
OLD\_View of damaged millwork finish.

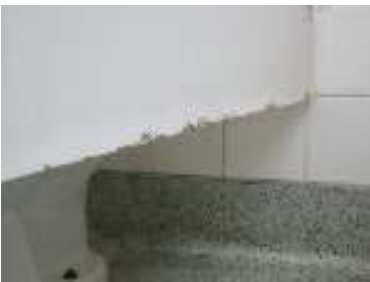
August 2012 - Damaged and delaminated partition observed

2012 - The washroom partitions are approaching their expected useful life. Based on age and observed condition, replacement is

recommended.

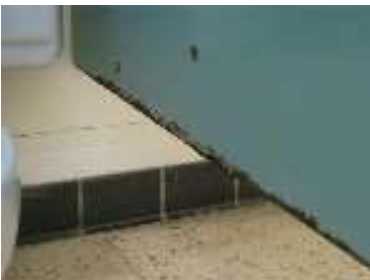
August 2012 - Corrosion at the bottom observed

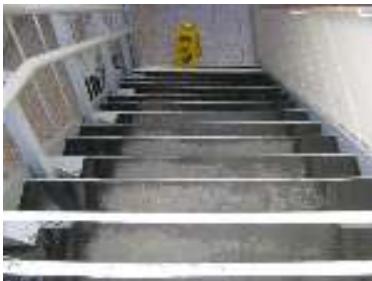
2012 – The metal framed interior stairs are in fair overall condition. The tread finishes are worn and damaged.

August 2012 - General view of concrete finished stairs

2012 - The metal framed interior stairs are approaching their expected useful life. Further deterioration of the stair framing and treads may result in loss of structural integrity as well as increase slipping and tripping hazards. Based on age and observed condition, replacement is recommended.

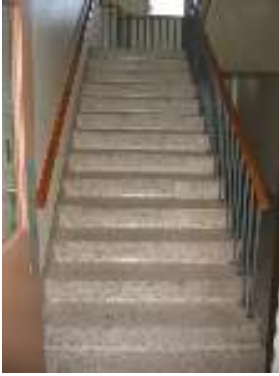
OLD\_View of the interior stairs.

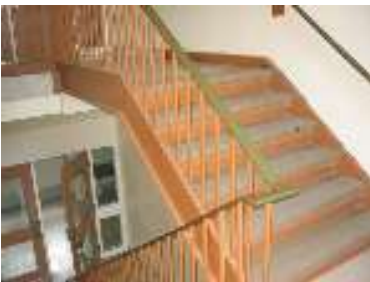
OLD\_View of the interior stairs.

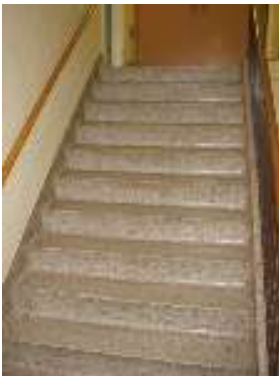
OLD\_View of the interior stairs.

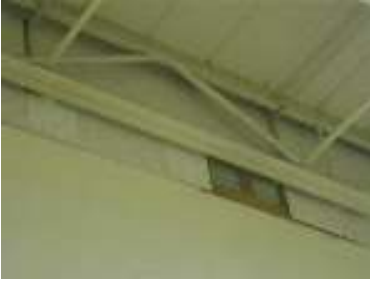
2012 - The acoustic panels are reported to be original to construction and are in poor condition, with staining, deterioration and physical damage observed at the time of the assessment.

August 2012 - General view of acoustic wall panels in gymnasium A

2012 – The acoustic wall panels have exceeded their expected useful life. Based on their age and observed condition, replacement of the acoustic wall panels is recommended.

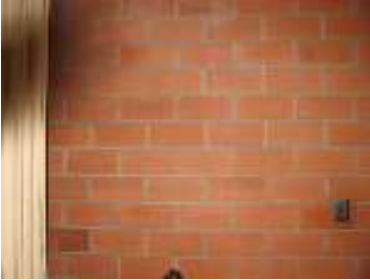
OLD\_View of the interior brick wall.

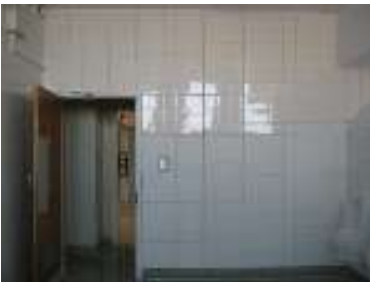
2012 - The ceramic wall tiles were reported to be original to building construction and are in fair overall condition. The tiles were observed to be cracked.

August 2012 - General view of ceramic tiles in washroom

2012 – The ceramic wall tiles is beyond its expected useful life. Based on age and observed condition, replacement of the ceramic wall tiles is recommended.

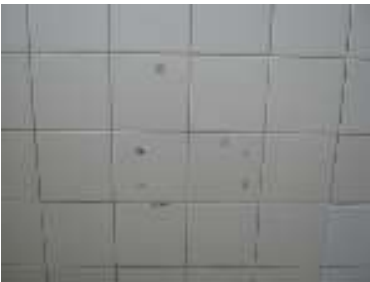
August 2012 - Damaged wall tiles observed

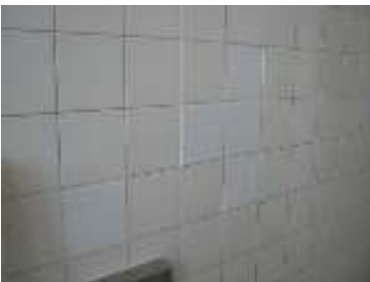
August 2012 - Past repairs observed

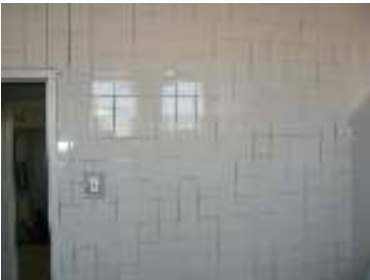
OLD\_General view of the wall tile.

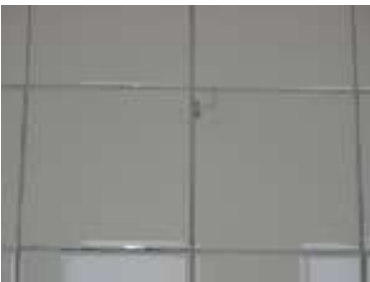
OLD\_View of damaged tile.

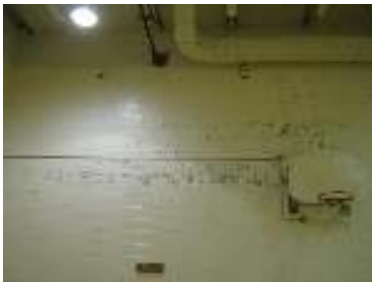
condition in the building. Areas of faded, peeling and damaged painted surfaces were observed at the time of the assessment, detracting from the overall interior aesthetics of the building.

August 2012 - General view of paint wall covering

2012 - Approximately 60% of paint wall covering has exceeded its expected useful life. Based on age and observed condition, replacement is recommended.

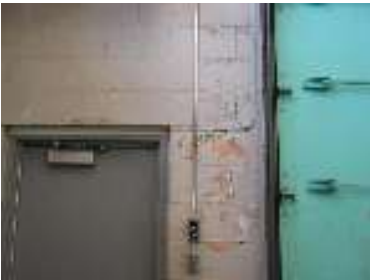
August 2012 - Peeling paint wall covering

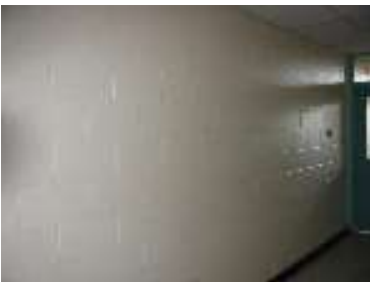
OLD\_View of painted wall covering.

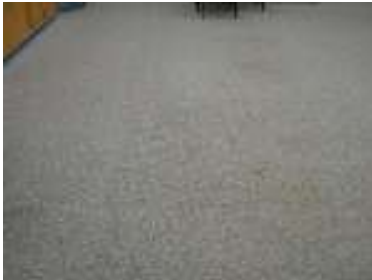
2012 - The carpet was observed to be in fair overall condition, with

frayed carpet and seams observed. Several sections of the carpet were noted to have staining, wrinkles and excessive wear.

August 2012 - Aged and worn appearance of carpet flooring

2012 - The carpet flooring is approaching its expected useful life. Based on age and observed condition, replacement is recommended.

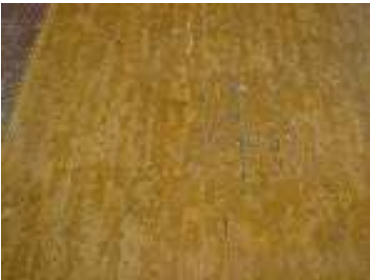
2012 – The hardwood flooring is in fair condition overall, with stained and worn areas observed.

August 2012 - Worn and deteriorated hardwood flooring observed

2012 - The hardwood flooring is beyond its expected useful life and exhibits wear typical of its age. Based on age and observed condition, replacement is recommended.

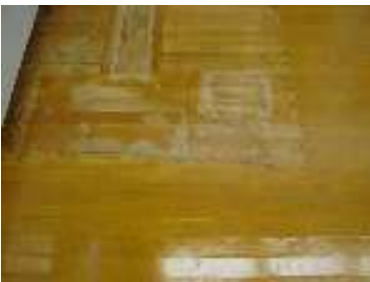
August 2012 - Debonded flooring and past repair observed

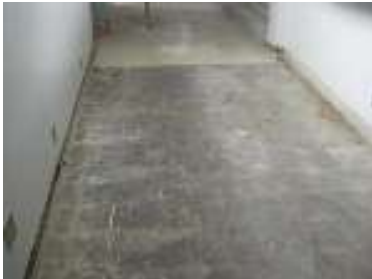
2012 - The painted concrete floors are in fair condition, with several

areas of worn and peeling paint noted.

August 2012 - General view of painted concrete floor

2012 - The paint appears is beyond its expected useful life and exhibits significant wear. Based on age and observed condition, replacement is recommended.

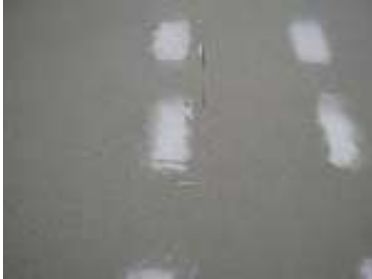
2012 - The sheet vinyl flooring is in poor overall condition, with areas of curling, delaminating and debonding of the sheet vinyl observed.

August 2012 - Curling of sheet vinyl flooring

2012 - The sheet vinyl flooring is generally aged and deteriorating. Further deterioration may result in unsafe conditions. Based on age

and observed condition, replacement of the sheet vinyl is recommended.

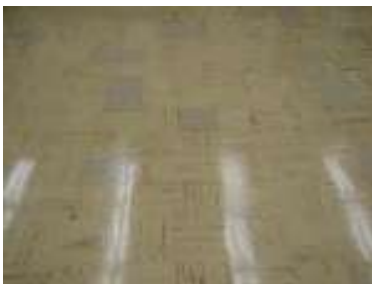
2012 - The vinyl tile flooring is of various vintages, with some recent installations but appears to be mainly original to the construction of the building. The tile is in fair overall condition, with worn floor tiles observed.

August 2012 - General view of vinyl tile flooring

2012 - The majority of the vinyl tile flooring in the building is beyond its expected useful life, exhibiting wear and deterioration typical of its age. Based on age and observed condition, replacement is recommended.

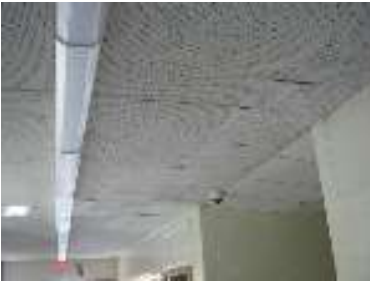
2012 - The fixed acoustic tile ceilings appear to be original to building construction and are in poor overall condition, with stained and debonded tiles observed.

August 2012 - General view of acoustic tile ceiling

2012 - The fixed acoustic tile ceilings are beyond their expected useful life. Based on age and observed condition, replacement is recommended.

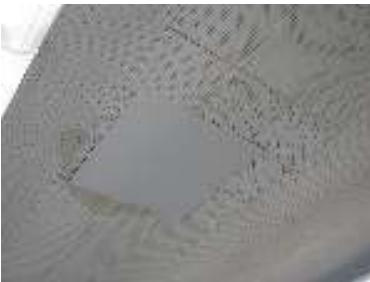
August 2012 - Past repairs observed

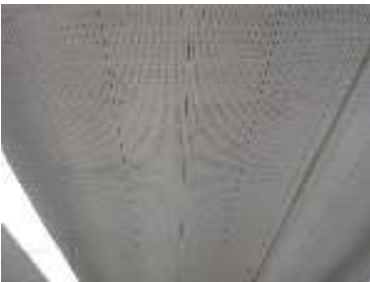
August 2012 - Stained and aged ceiling tiles observed

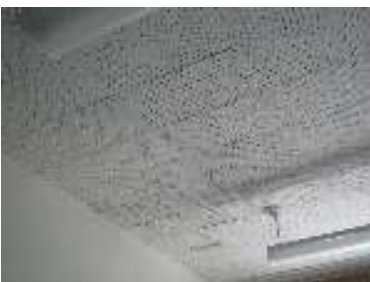
August 2012 - Debonded and deteriorated ceiling tiles observed

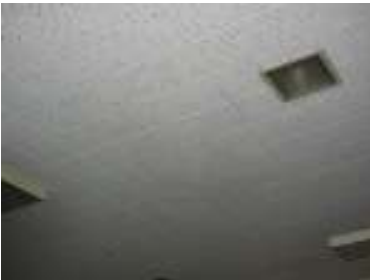
OLD\_View of damaged ceiling tile.

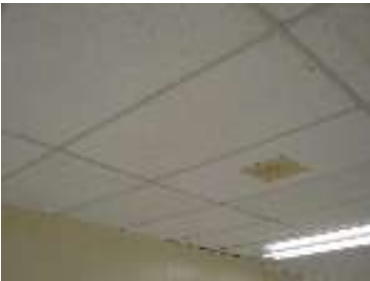
August 2012 - General view of suspended acoustic panel ceiling

2012 - The suspended acoustic panel ceilings are approaching their expected useful life and exhibit wear and deterioration typical of their age. Based on age and observed condition, replacement is recommended.

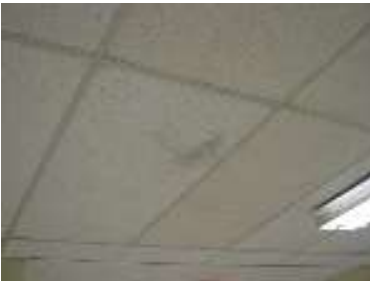
August 2012 - Stained and aged ceiling panels observed

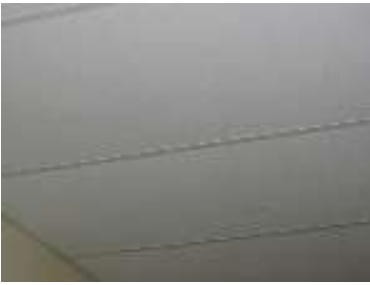
OLD\_View of suspended acoustic ceiling.

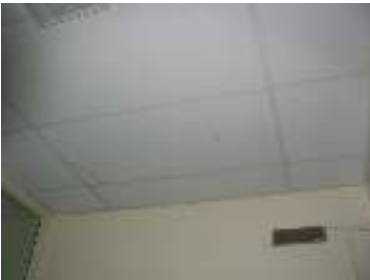
OLD\_View of a damaged suspended acoustic ceiling.

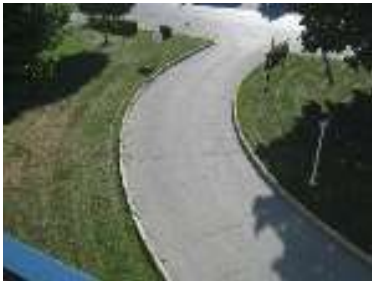
August 2012 - General view of asphalt paved roadway

2012 - The asphalt pavement and associated concrete curbing of the driveway is beyond its expected useful life. Based on age and observed condition, replacement is recommended.

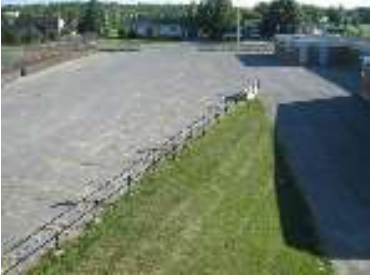
August 2012 - General view of asphalt paved parking lot

2012 - The asphalt pavement of the parking lot of south and west

sides has exceeded their expected useful life. Based on age and observed condition, replacement of the asphalt parking surface is recommended.

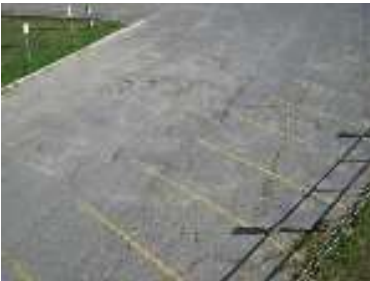
August 2012 - Heaved and ravelled asphalt pavement as well as pothole observed

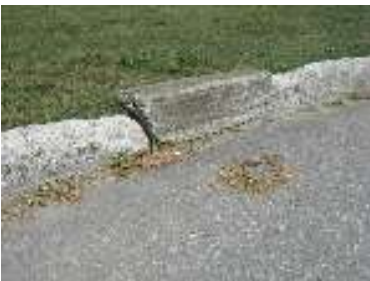
August 2012 - Damaged and deteriorated concrete curbing observed

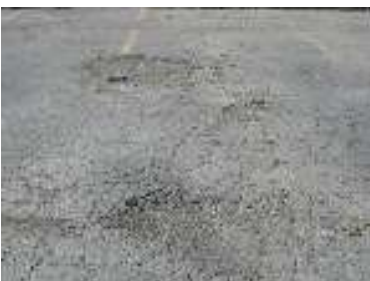
August 2012 - Pothole and rutting of asphalt pavement observed

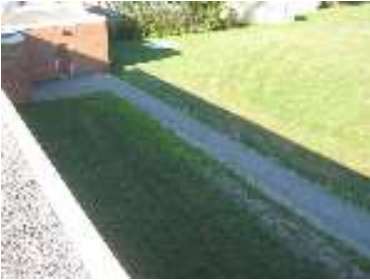
August 2012 - General view of asphalt paved walkway

2012 - The asphalt and concrete paved walkways are beyond their expected useful life, with cracked and heaved areas considered potential tripping hazards of concrete curbs. Based on age and observed condition, replacement is recommended.

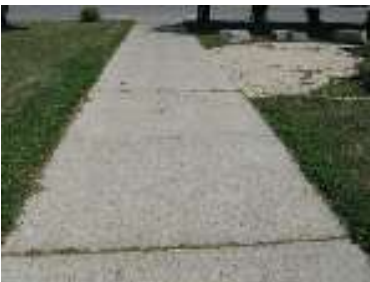
August 2012 - General view of concrete paved walkway

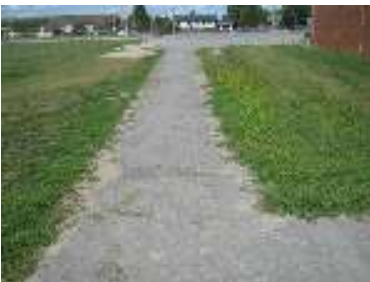
August 2012 - Map cracking and ravelled asphalt pavement observed

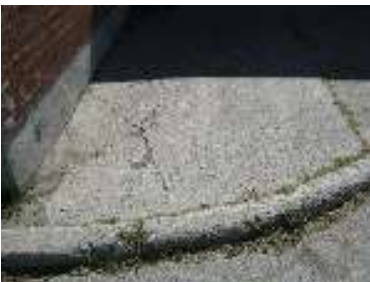
August 2012 - Cracked concrete pavement observed

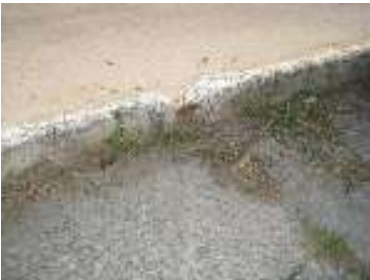
August 2012 - Exposed reinforcement in concrete curbing observed

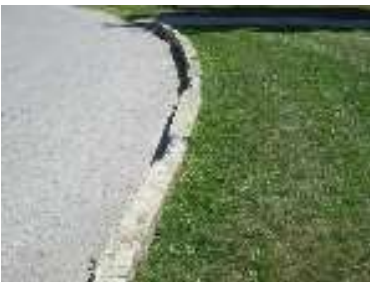
August 2012 - Spalled and deteriorated concrete curbing observed

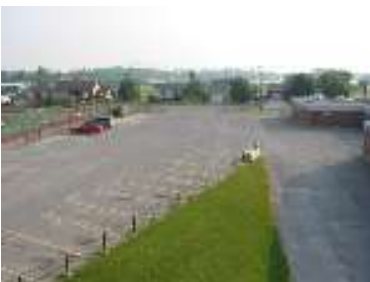
OLD\_General view of the paved area.

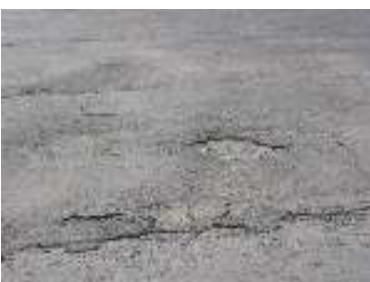
OLD\_View of potholes and alligator cracking.

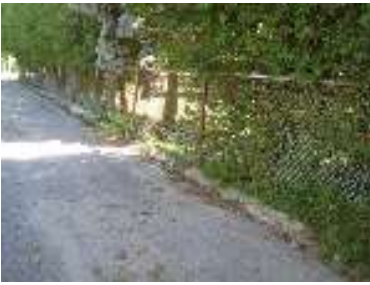
2012 - The chain-ink fencing of the site is in poor overall condition, with corrosion and frost jacked posts observed at the time of assessment.

August 2012 - General view of chain-link fencing

2012 - The chain-link fencing is beyond its expected useful life. Based on age and observed condition, replacement is recommended.

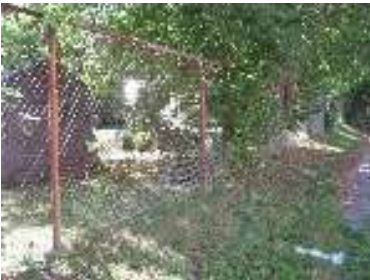
August 2012 - Corroded posts and rails observed

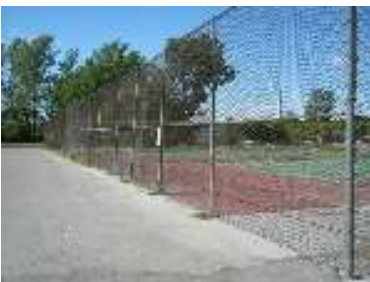
August 2012 - Leaning posts along the tennis court fencing

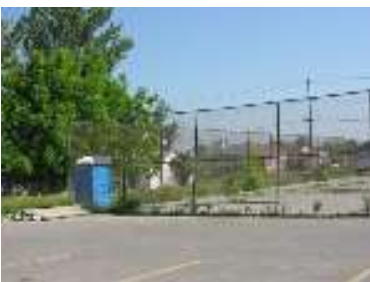
OLD\_View of fence around tennis court.

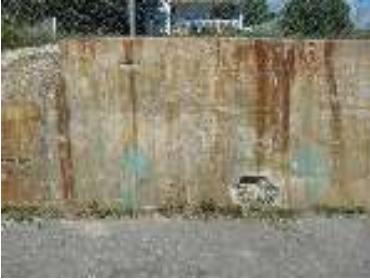
2012 - The cast-in-place concrete retaining wall is in poor overall condition. At the time of the assessment, the retaining wall was observed to be cracking and spalling and crumbling in some locations.

August 2012 - Spalled and deteriorated concrete wall observed

2012 - The cast-in-place concrete retaining wall has exceeded its expected useful life. Based on observed conditions, it appears the structural integrity of the wall is reduced and it is no longer functioning as intended. Replacement is recommended.

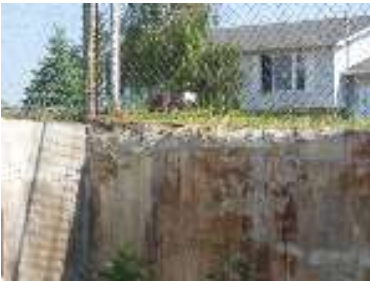
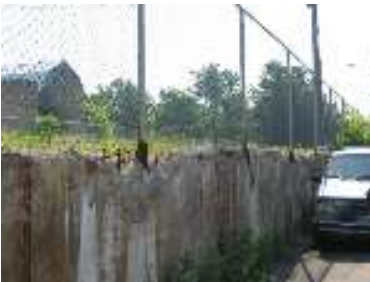
OLD\_View of the retaining wall.

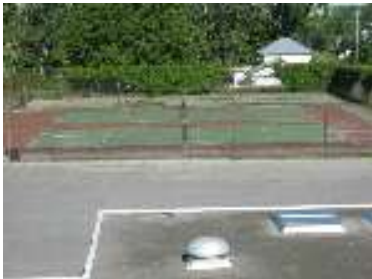
2012 - The asphalt paved schoolyard is in poor overall condition. At the time of the assessment, transverse and longitudinal cracking was noted. All of which indicates that the pavement and its sub-structure is beginning to fail.

August 2012 - General view of asphalt paved tennis court

2012 - The asphalt paved schoolyard is beyond its expected useful life. Based on age and observed condition, replacement of the asphalt is recommended.

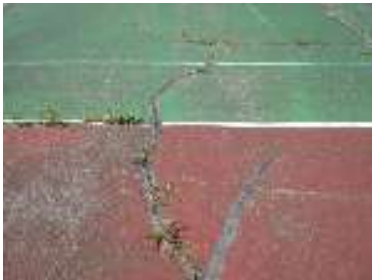
August 2012 - Cracking on asphalt pavement observed
